## Beachwatch

# State of the beaches 2023–24

Statewide summary and how to read this report

Department of Climate Change,  
Energy, the Environment and Water

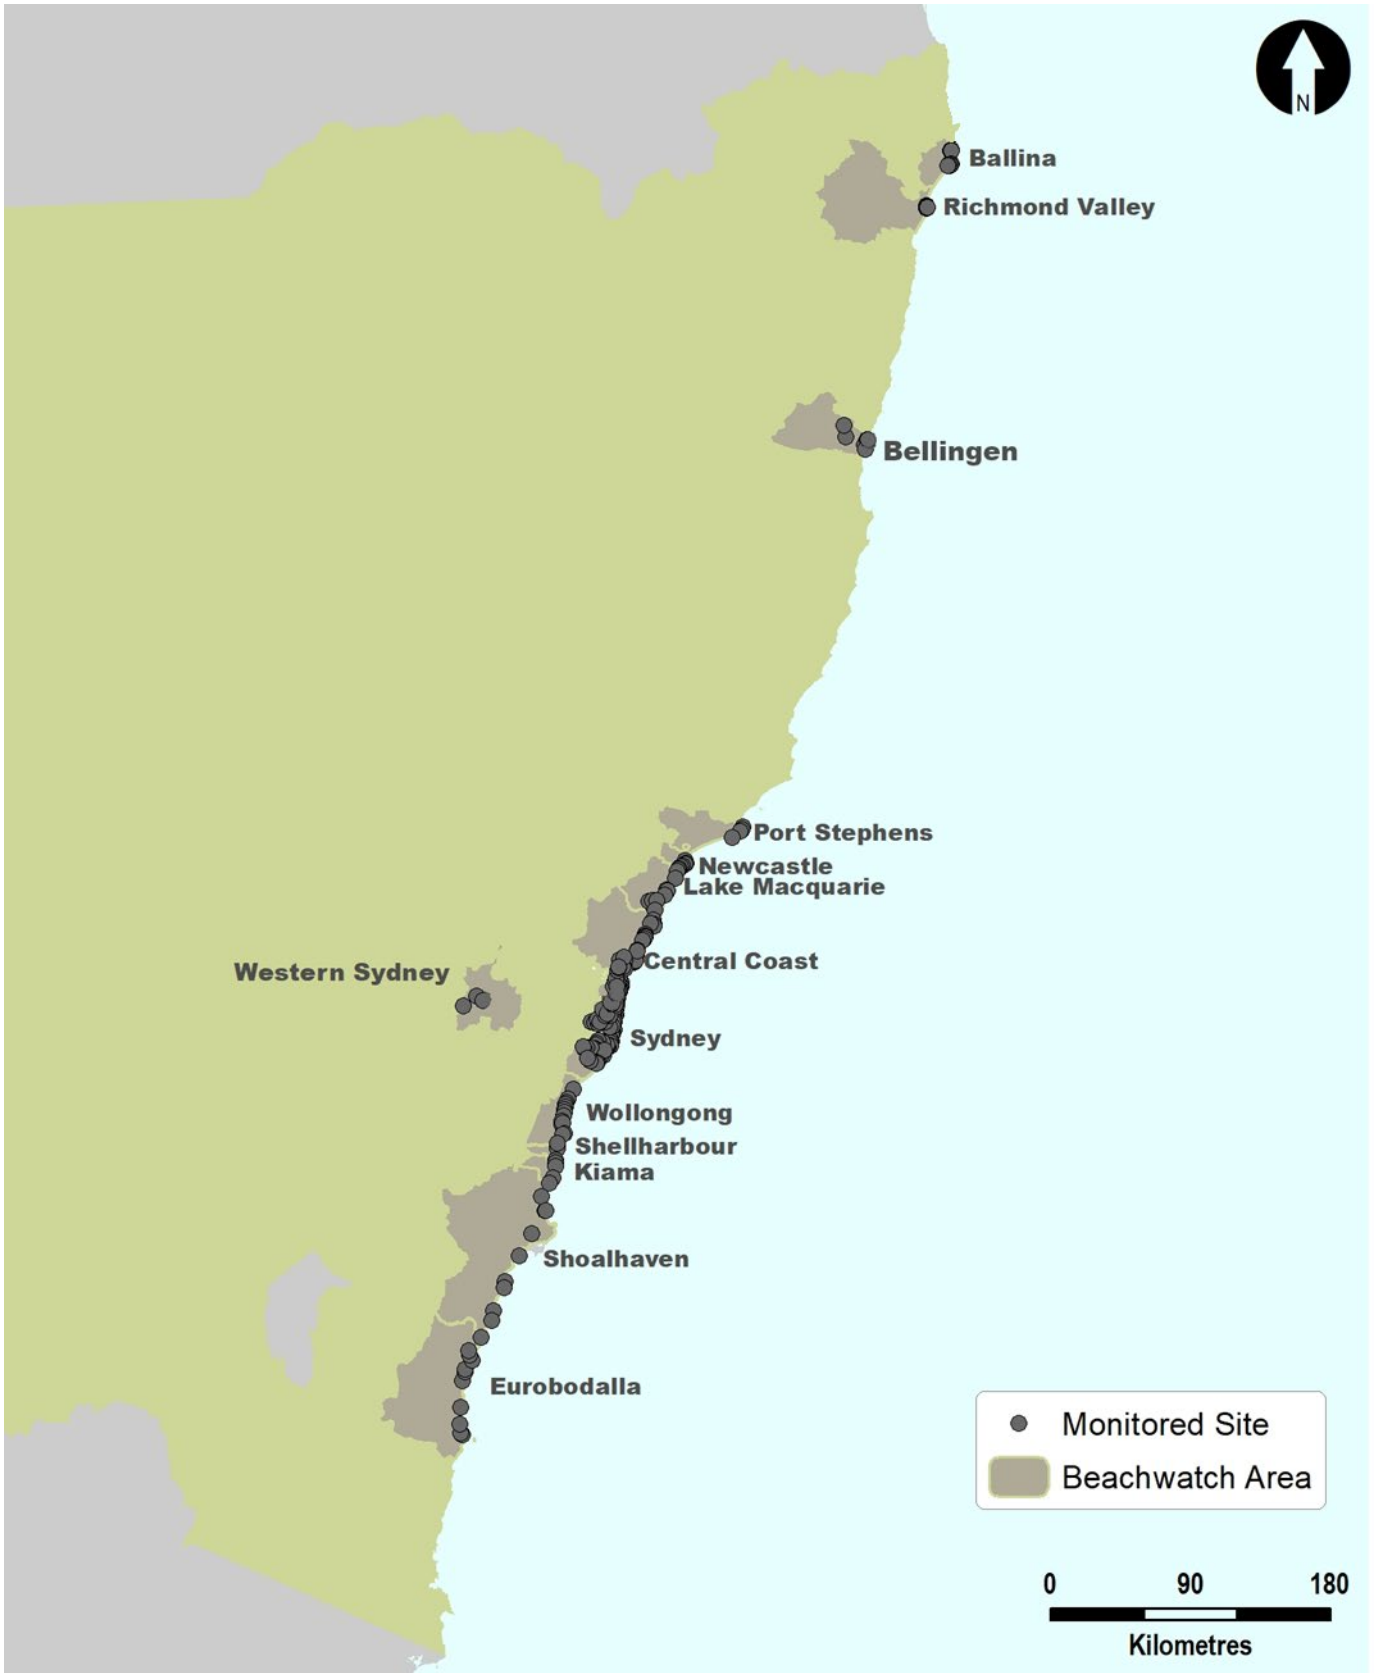
Sampling sites and areas monitored in New South Wales under the Beachwatch programs

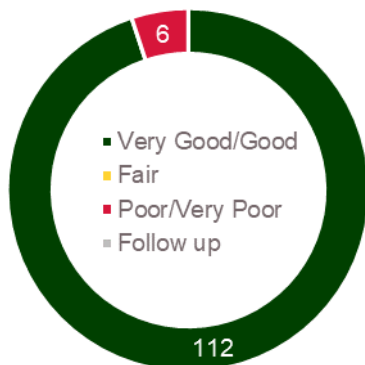
**Beach Suitability Grades for monitored ocean beaches in New South Wales**

The open ocean beaches of New South Wales had excellent water quality in 2023–2024 with 95% of 118 monitored ocean beaches graded as Very Good or Good. This indicates they were suitable for swimming most or almost all of the time. This performance is a slight decline on the 2022–2023 result, when 96% of 123 ocean beaches were graded as Very Good or Good.

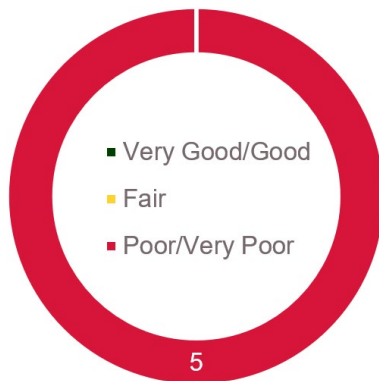
**Beach Suitability Grades for monitored freshwater swimming sites in New South Wales**

All 5 freshwater swimming sites were graded as Poor or Very Poor in 2023–2024.

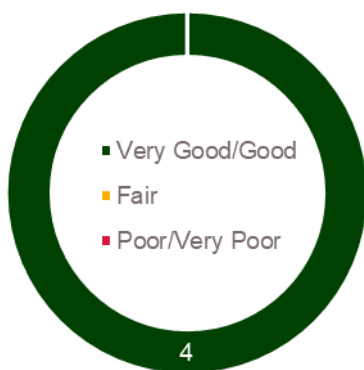
**Beach Suitability Grades for monitored ocean baths in New South Wales**

The water quality at ocean baths often depends on the flushing regime. While The Entrance Ocean Baths is regularly cleaned by council, other ocean baths are flushed irregularly, relying on the natural exchange of ocean water over the rocks and pool walls. It is recommended that swimming be avoided during and for up to one day after rainfall, or if there are signs of pollution such as discoloured water or floating debris.

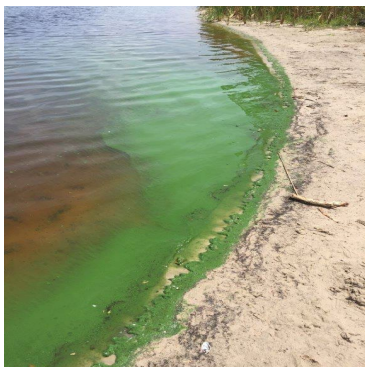
Blue-green algal bloom present in the water  
 Photo: Rachael Jenner/  
 Ballina Shire Council

Water NSW and Ballina Shire Council reported the occurrence of freshwater blue-green algal blooms due to *Microcystis aeruginosa* impacting Lake Ainsworth from September to December 2023 and in January and April 2024. Further caution alerts were issued for Lake Ainsworth in May 2023 due to the presence of surface scum with water users advised to avoid impacted areas.

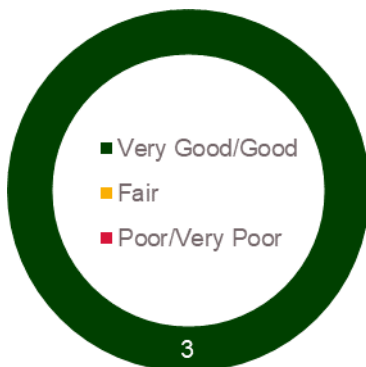
**Beach Suitability Grades for Ballina Shire Council ocean beaches**

Seven Mile Beach, Shelly Beach and Lighthouse Beach continued to be graded as Very Good in 2023–2024. These beaches had excellent water quality and were suitable for swimming almost all of the time.

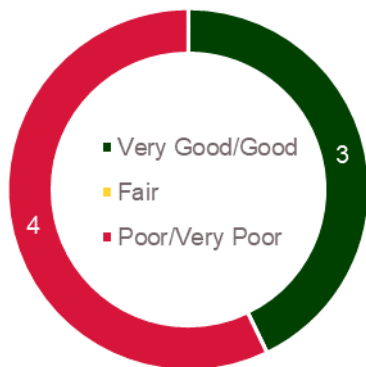
**Beach Suitability Grades for Ballina Shire Council estuarine beaches**

Three of the 7 estuarine swimming locations were graded as Good in 2023–2024: Shaws Bay East Arm, Shaws Bay East Beach and The Serpentine. Water quality at these sites was frequently suitable for swimming in dry weather, with 96% or greater of dry weather samples within the safe swimming limit.

Four estuarine swimming sites were graded as Poor in 2023–2024: Shaws Bay North, Shaws Bay East, Shaws Bay West and Missingham Beach. Shaws Bay East was downgraded from Good in the previous year due a decline in microbial water quality. The Poor grade for Missingham Beach is provisional as the assessment is based on limited bacterial data.

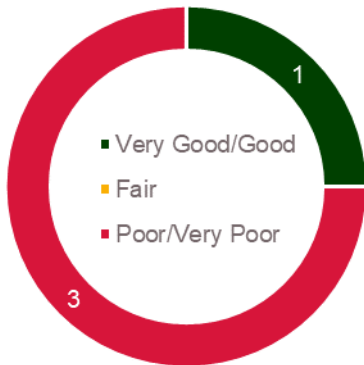
**Beach Suitability Grades for Ballina Shire Council lake/lagoon swimming sites**

Lake Ainsworth South continued to be graded as Good in 2023–2024. This site was mostly suitable for swimming during dry weather, with 84% of dry weather samples within the safe swimming limit. Elevated enterococci levels were frequently recorded at this site after heavy rainfall.

Lake Ainsworth North, Lake Ainsworth East and Lake Ainsworth West were graded as Poor in 2023–2024, a result consistent with previous years. Elevated bacteria levels were recorded at these lake swimming sites during dry and wet weather conditions. Despite the poor grades, between 66% and 78% of dry weather samples were within the safe swimming limit. These sites may be impacted by a number of significant potential sources of faecal contamination, including stormwater, and have low levels of flushing.

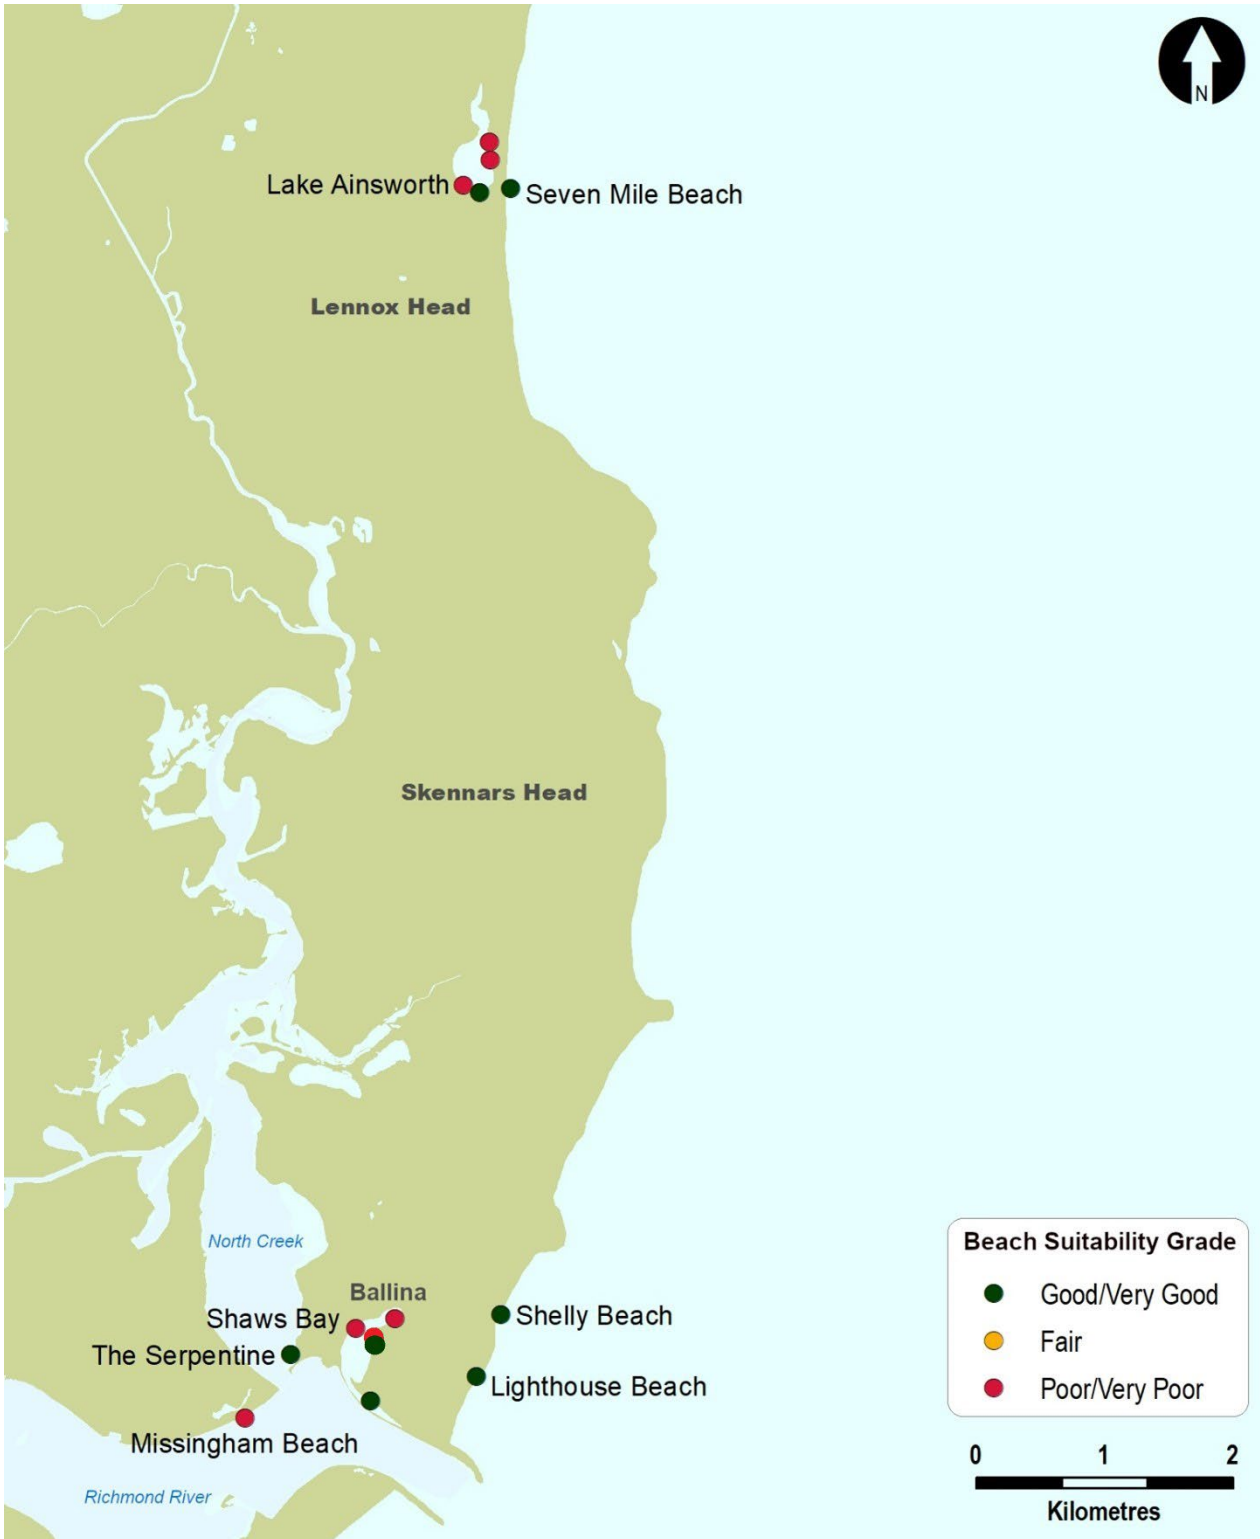
**Sampling sites and Beach Suitability Grades in Ballina Shire Council**

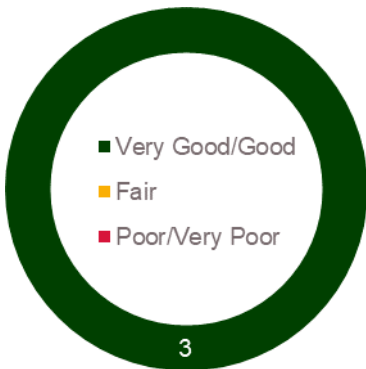
**Beach Suitability Grades for Richmond Valley Council ocean beaches**

Shark Bay was graded as Very Good in 2023–2024. Water quality at this beach has been consistently excellent for many years and is suitable for swimming almost all of the time.

Airforce Beach and Main Beach continued to be graded as Good in 2023–2024, a similar result to previous years. While water quality at these beaches was suitable for swimming most of the time, elevated enterococci results were occasionally recorded in dry and wet weather conditions.

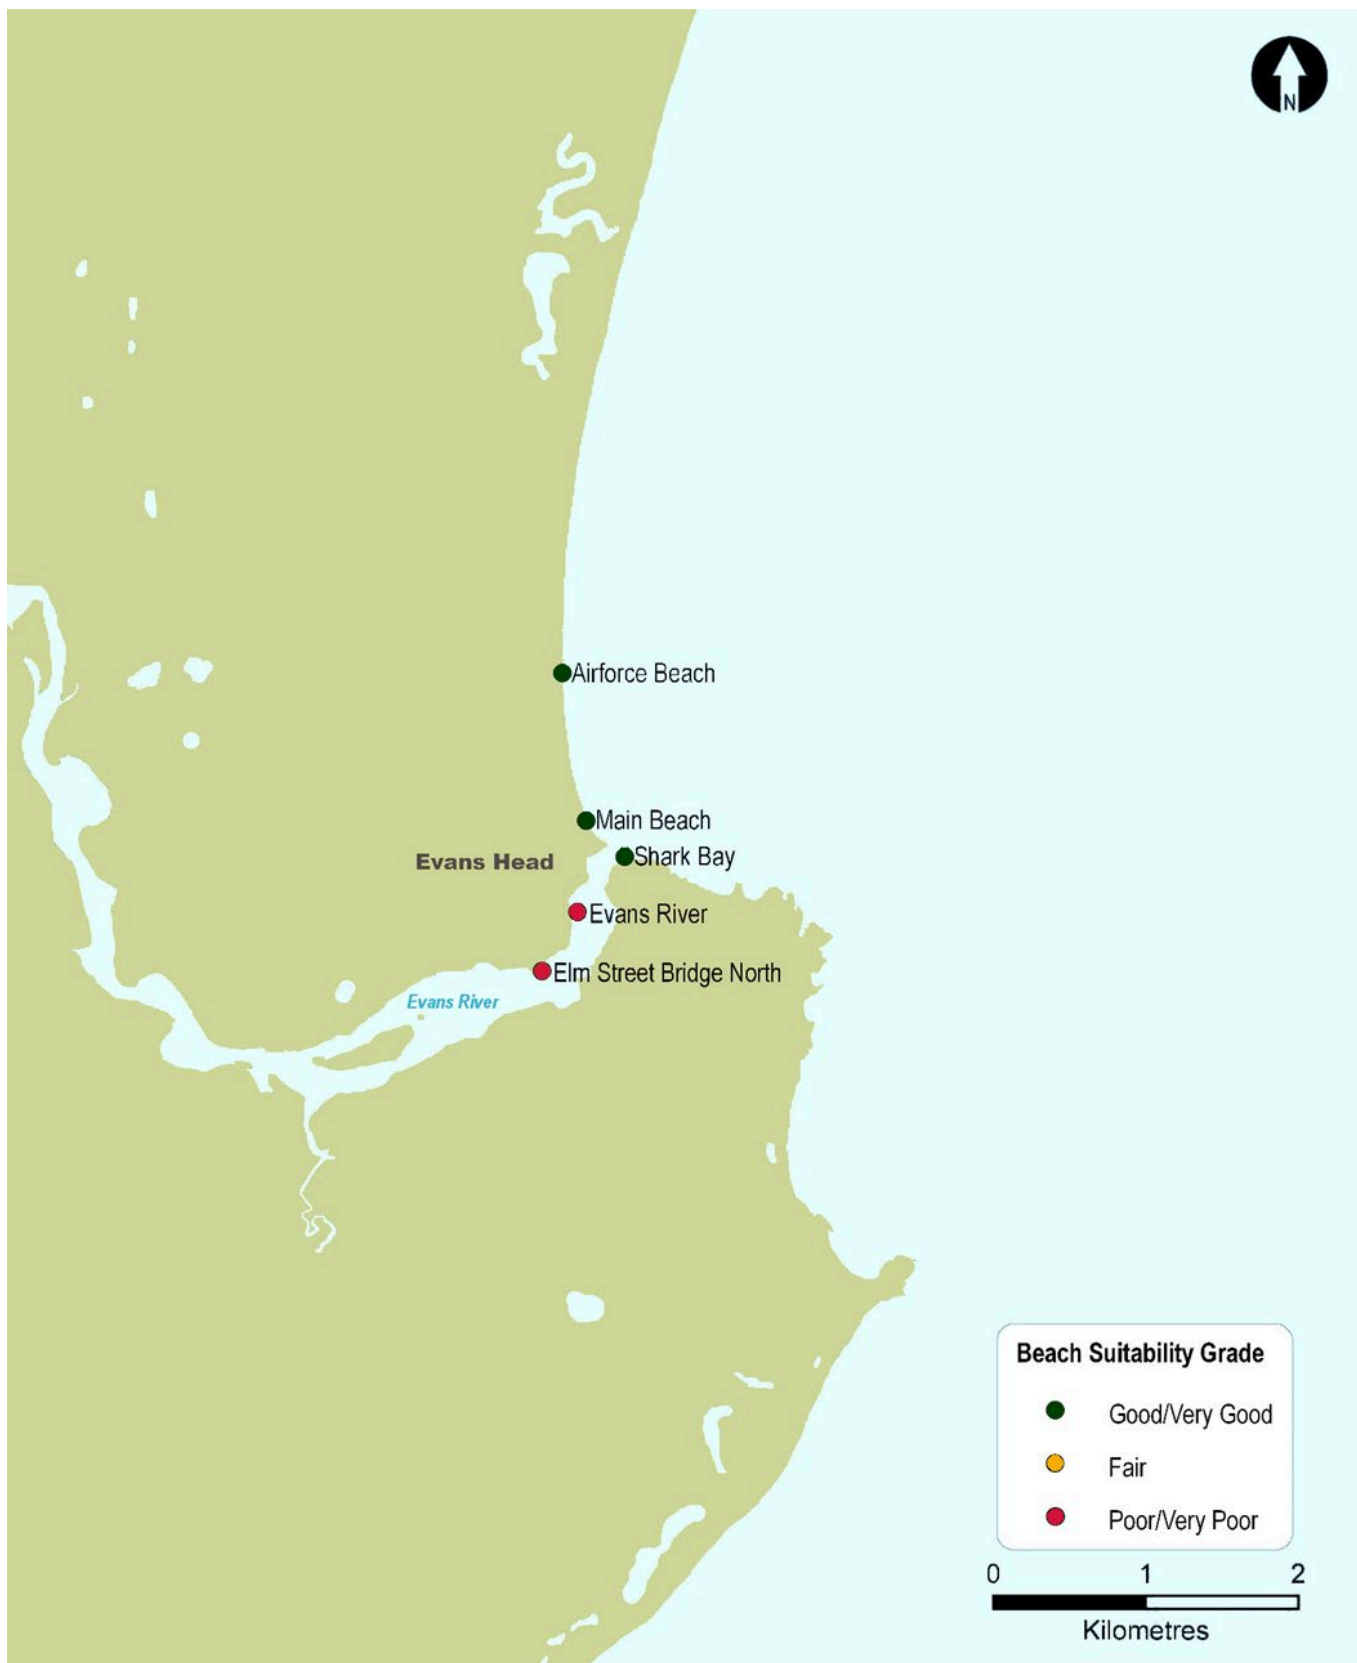
**Sampling sites and Beach Suitability Grades in Richmond Valley Council**

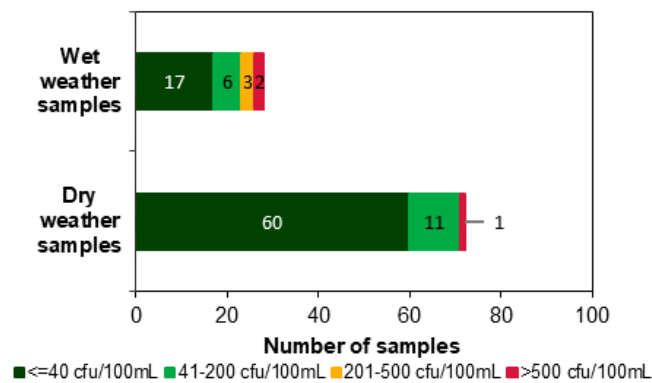
## Wet and dry weather water quality chart

Enterococci levels in wet and dry weather conditions are presented for each swimming location as a bar graph. All data collected during the assessment period is included in the analysis. Dry weather is defined as no rainfall recorded in the previous 24 hours. Each bar is colour coded to show the number of enterococci results up to 40 cfu/100 mL, between 41 and 200 cfu/100 mL, between 201 and 500 cfu/100 mL and greater than 500 cfu/100 mL. These categories reflect the Microbial Assessment Category thresholds and are coloured on the graph as dark green, light green, amber and red respectively.

It is expected that swimming sites with lower levels of flushing will show some elevated bacterial results in dry weather samples (no rainfall in the previous 24 hours) due to the longer time needed to recover from a rainfall event. At some estuarine and lake/lagoon swimming locations the impacts of stormwater pollution on beach water quality may be detected up to 3 days after rainfall.

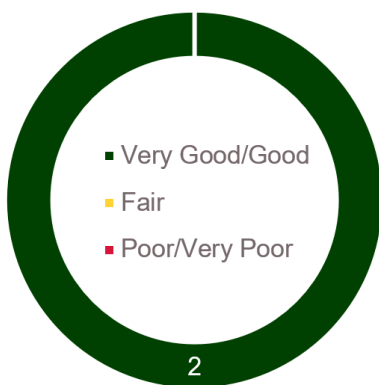
Hungry Head Beach and North Beach were graded as Good in 2023–2024. Hungry Head Beach improved to Good from Poor in the previous year. Water quality at these beaches was suitable for swimming most of the time, with 83% and 94% of dry weather samples within the safe swimming limit at Hungry Head Beach and North Beach respectively.

Beach Suitability Grades for Bellinghen Shire Council ocean beaches

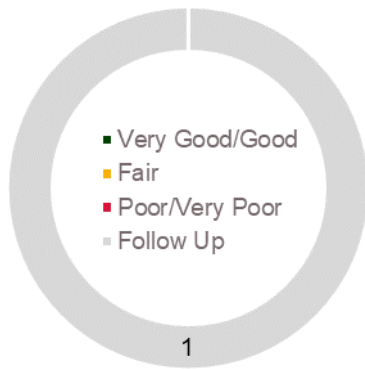
**Beach Suitability Grades for Bellingen Shire Council lagoon site**

Dalhousie Creek was graded as Follow Up in 2023–2024, due to incongruent results from the sanitary inspection and microbial water quality. While this grade is provisional, microbial water quality was mostly suitable for swimming during dry weather conditions, with 74% of dry weather samples within the safe swimming limit. Elevated bacterial levels increased with increasing rainfall, and frequently exceeded the safe swimming limit after moderate rainfall.

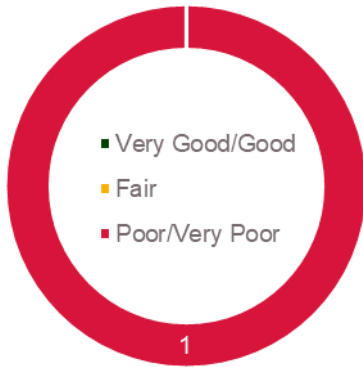
**Beach Suitability Grades for Bellingen Shire Council freshwater site**

Arthur Keough Reserve was graded as Poor in 2023–2024, similar to the previous year. This grade is provisional and subject to change as data available for the microbial assessment is incomplete.

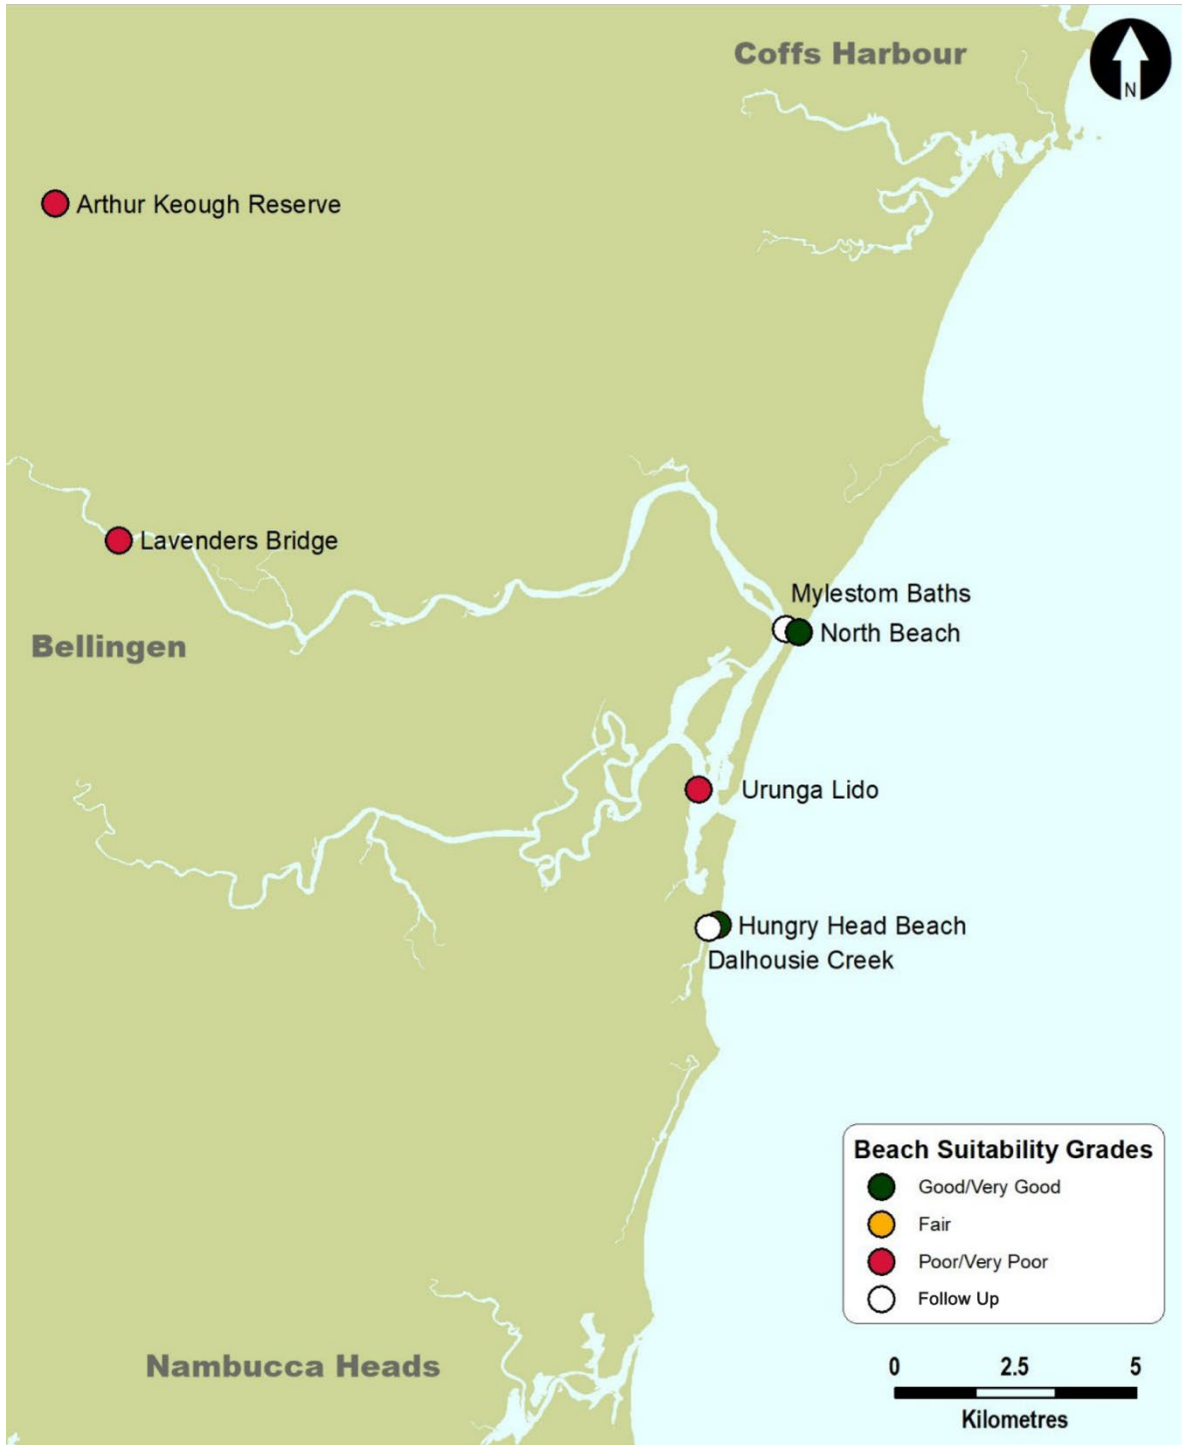
**Sampling sites and Beach Suitability Grades in Bellingen Shire Council**

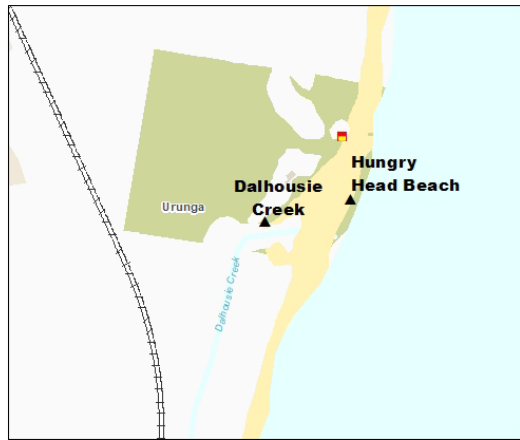
See ‘How to read this report’ for key to map.

Dalhousie Creek is located in a small coastal lagoon with an intermittently closed/open entrance which lies just to the south of Hungry Head.

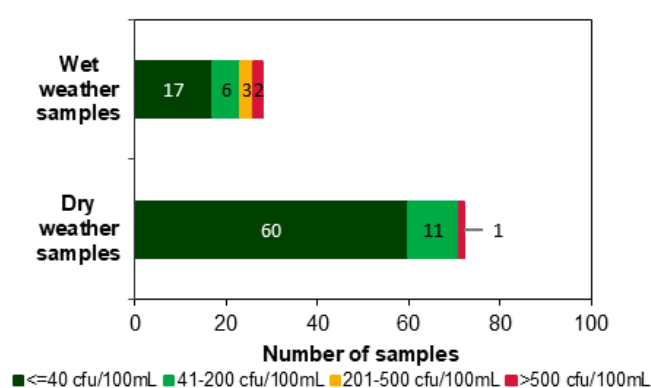
## Wet and dry weather water quality chart

Enterococci levels in wet and dry weather conditions are presented for each swimming location as a bar graph. All data collected during the assessment period is included in the analysis. Dry weather is defined as no rainfall recorded in the previous 24 hours. Each bar is colour coded to show the number of enterococci results up to 40 cfu/100 mL, between 41 and 200 cfu/100 mL, between 201 and 500 cfu/100 mL and greater than 500 cfu/100 mL. These categories reflect the Microbial Assessment Category thresholds and are coloured on the graph as dark green, light green, amber and red respectively.

It is expected that swimming sites with lower levels of flushing will show some elevated bacterial results in dry weather samples (no rainfall in the previous 24 hours) due to the longer time needed to recover from a rainfall event. At some estuarine and lake/lagoon swimming locations the impacts of stormwater pollution on beach water quality may be detected up to 3 days after rainfall.

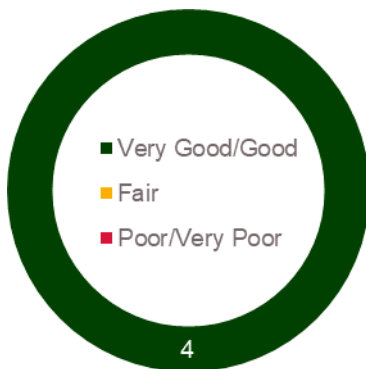
All 4 ocean beaches were graded as Very Good in 2023–2024: Zenith Beach, Box Beach, Fingal Beach and One Mile Beach. Water quality at these sites has continued to be excellent and was suitable for swimming almost all of the time.

**Beach Suitability Grades for Port Stephens Council ocean beaches**

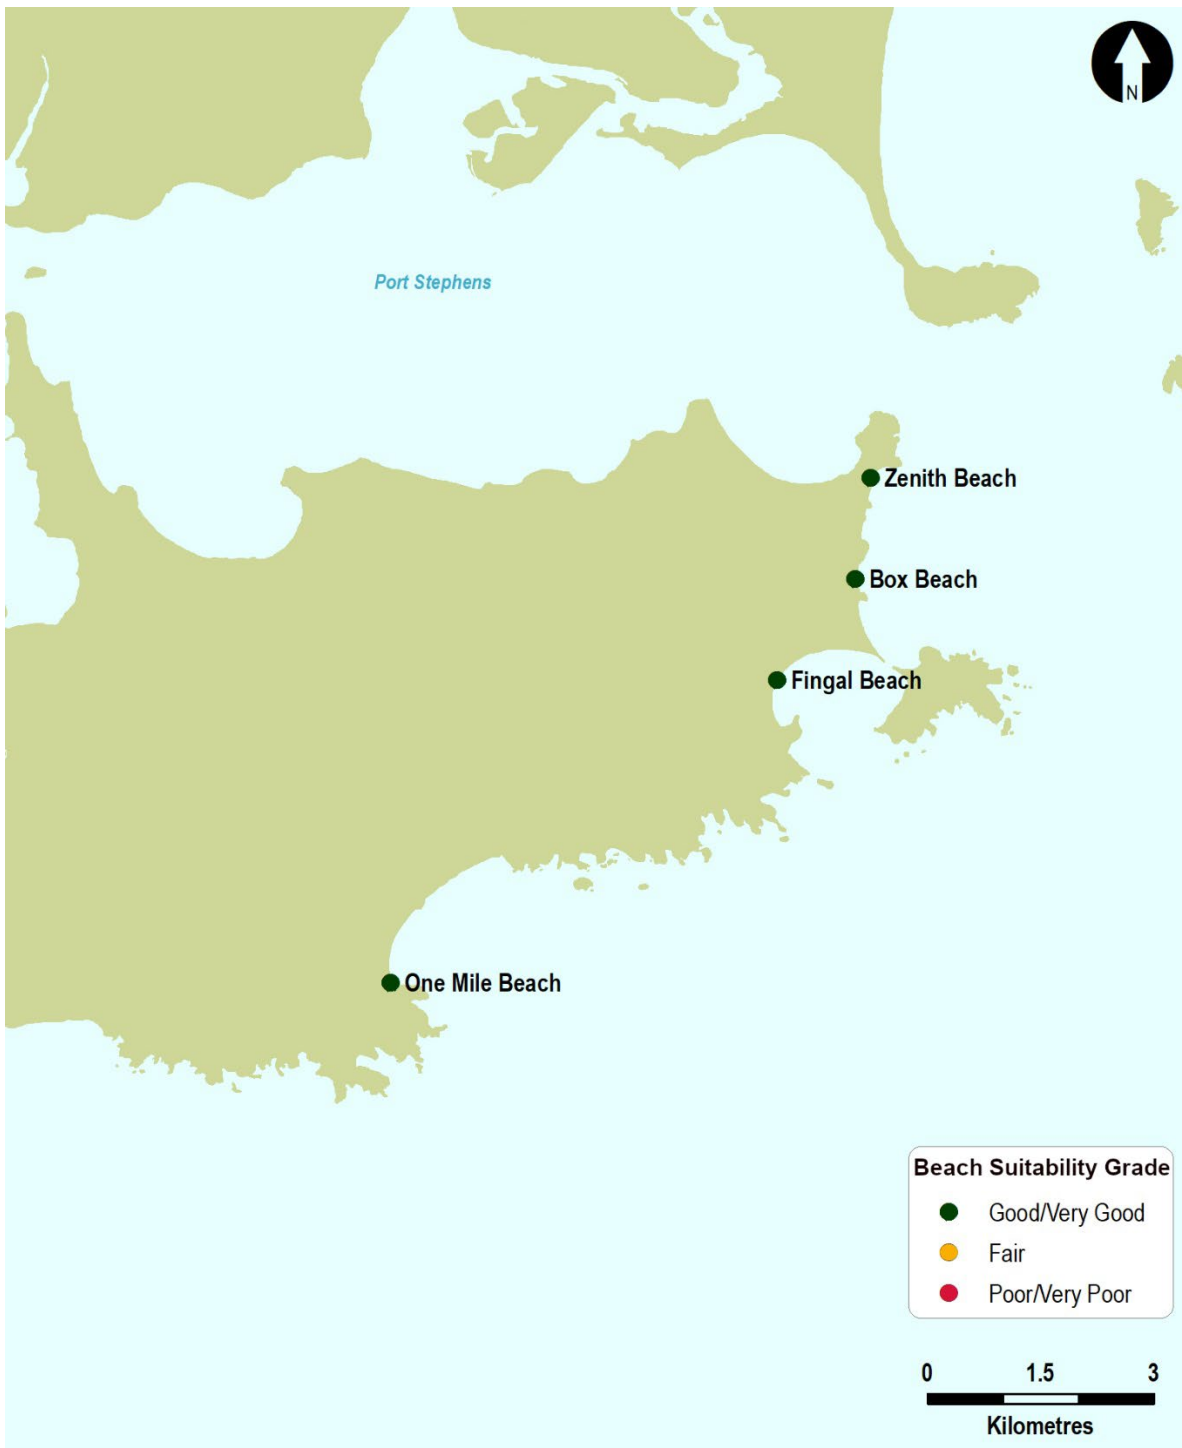
**Sampling sites and Beach Suitability Grades in Port Stephens Council**

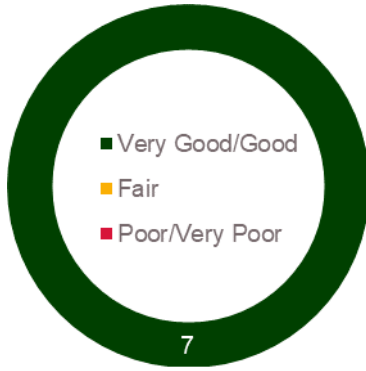
**Beach Suitability Grades for  
City of Newcastle Council  
ocean beaches**

All 7 ocean beaches continued to be graded as Very Good in 2023–2024: Stockton Beach, Nobbys Beach, Newcastle Beach, Bar Beach, Merewether Beach, Burwood North Beach and Burwood South Beach. Water quality at these sites was suitable for swimming almost all of the time and has been of a high standard for many years.

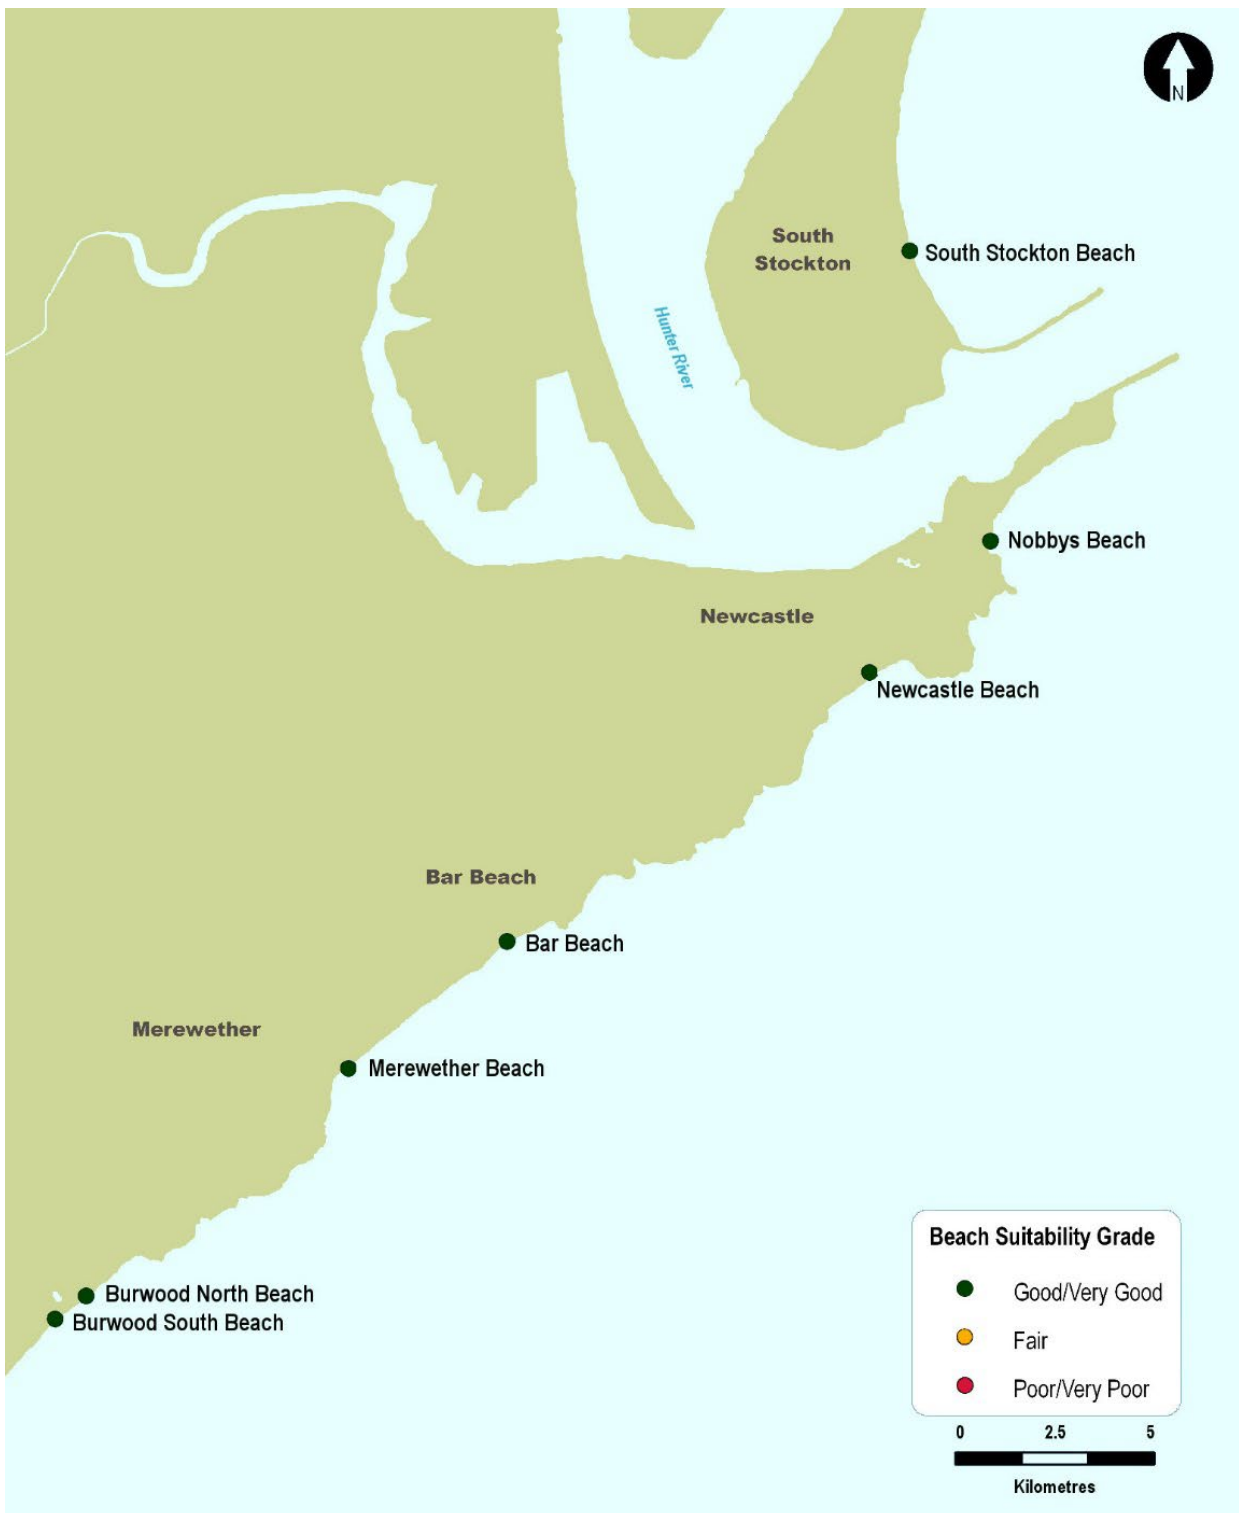
Sampling sites and Beach Suitability Grades in City of Newcastle Council

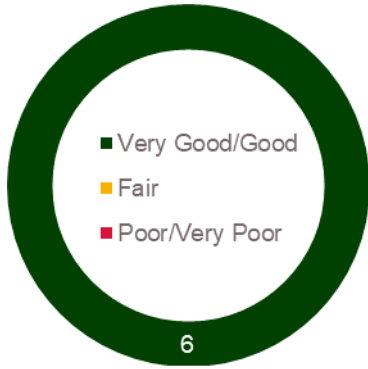
**Beach Suitability Grades for Lake Macquarie City Council ocean beaches**

Five of the 6 ocean beaches were graded as Very Good in 2023–2024: Glenrock Lagoon Beach, Dudley Beach, Redhead Beach, Blacksmiths Beach and Caves Beach. This is a similar result to the previous year. Water quality at these beaches is suitable for swimming almost all of the time.

Swansea Heads Little Beach continued to be graded Good in 2023–2024, consistent with the previous year. While the water quality was mostly suitable for swimming during dry weather conditions, with 89% of dry weather samples within the safe swimming limit, elevated levels often exceeded the safe swimming limit following light rainfall.

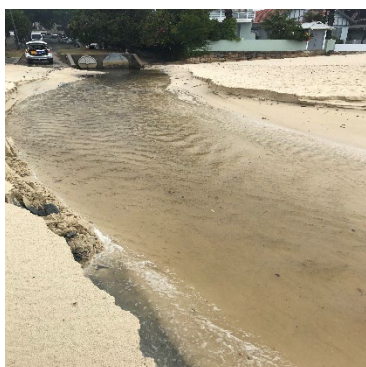
Stormwater drain flow

Stormwater in urban areas often contains sewage from leakages, overflows or sewer chokes when the sewerage system fails.

Sewage overflows can occur in wet weather when the network has exceeded capacity due to rainwater entering the system. The mix of sewage and rainwater discharges from designated overflow points and drains to waterways, usually via the stormwater system. Overflows from the sewerage system can also occur in dry weather due to mechanical failure or power outage.

Sewer chokes occur due to blockages in the pipes usually due to tree roots, oil, grease or debris. This causes sewage to back up and escape via sewer inspection points, designed overflow structures or cracks in the pipes, then drain to waterways, usually via the stormwater system.

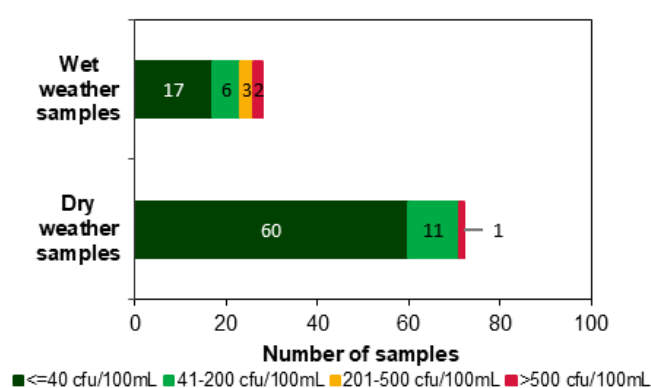
## Wet and dry weather water quality chart

Enterococci levels in wet and dry weather conditions are presented for each swimming location as a bar graph. All data collected during the assessment period is included in the analysis. Dry weather is defined as no rainfall recorded in the previous 24 hours. Each bar is colour coded to show the number of enterococci results up to 40 cfu/100 mL, between 41 and 200 cfu/100 mL, between 201 and 500 cfu/100 mL and greater than 500 cfu/100 mL. These categories reflect the Microbial Assessment Category thresholds and are coloured on the graph as dark green, light green, amber and red respectively.

It is expected that swimming sites with lower levels of flushing will show some elevated bacterial results in dry weather samples (no rainfall in the previous 24 hours) due to the longer time needed to recover from a rainfall event. At some estuarine and lake/lagoon swimming locations the impacts of stormwater pollution on beach water quality may be detected up to 3 days after rainfall.

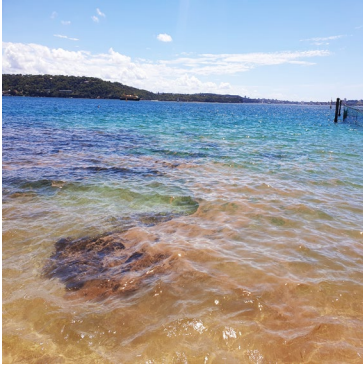
Marine algal bloom present in the water

The appearance of **marine algae** is sometimes mistaken for **sewage contamination** or **oil slicks**, due to a strong odour and red or brown discolouration in the water caused by the blooms.

As a precaution, direct contact with algae should be avoided as it can cause skin and eye irritations. The marine algal blooms dissipated with changes in tide and wind conditions.

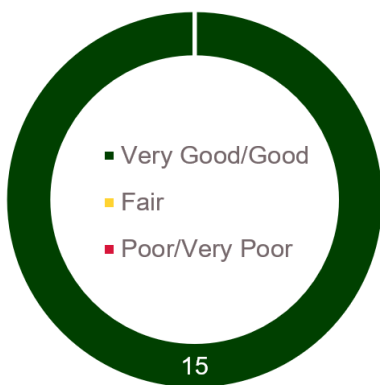
Beach Suitability Grades for Central Coast ocean beaches

Twelve of the 15 ocean beaches were graded as Good: The Entrance Beach, Toowoona Bay, Shelly Beach, Wamberal Beach, Terrigal Beach, North Avoca Beach, Avoca Beach, Copacabana Beach, MacMasters Beach, Killcare Beach, Ocean Beach and Umina Beach. Water quality at these

Lakes Beach, Soldiers Beach and North Entrance Beach were graded as Very Good in 2023–2024. While the grade for North Entrance Beach was consistent with the previous year, Lakes Beach and Soldiers Beach grades improved from Good in the previous year due to improved microbial water quality. Water quality at these sites was suitable for swimming almost all of the time.

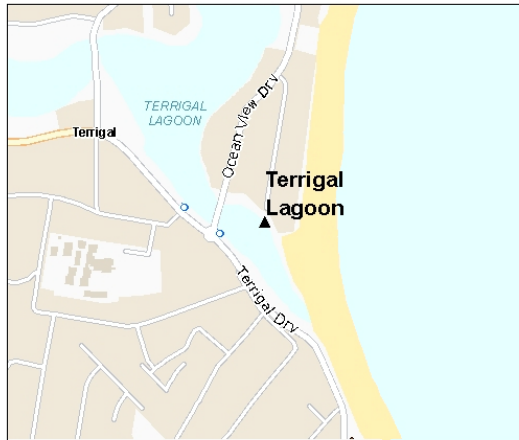
# Terrigal Lagoon

Terrigal Lagoon is intermittently open to the ocean to the north of Terrigal Beach.

The Beach Suitability Grade of Poor indicates microbial water quality is susceptible to faecal pollution, particularly after rainfall and occasionally during dry weather conditions, with several potential sources of faecal contamination including sewage overflows and from elsewhere within the lagoon.

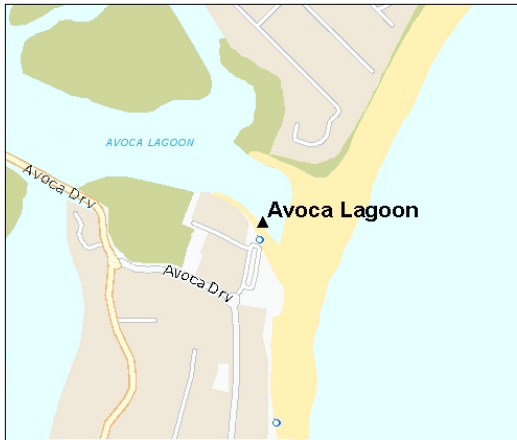
# Avoca Lagoon

Avoca Lagoon is intermittently open to the ocean and located to the north of Avoca Beach.

The Beach Suitability Grade of Poor indicates microbial water quality is susceptible to faecal pollution, particularly after rainfall and often during dry weather conditions, with several potential sources of faecal contamination including sewage overflows and from elsewhere within the lagoon.

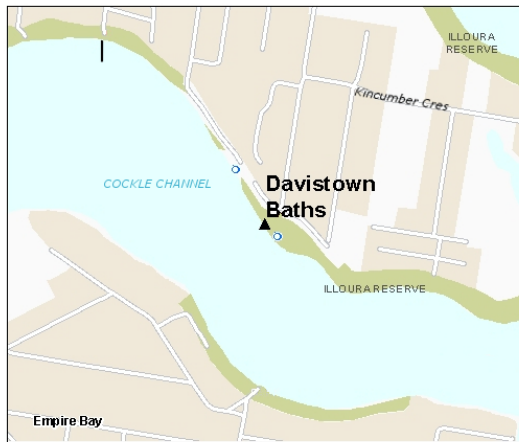
# Davistown Baths

The Davistown Baths are a netted swimming enclosure in the channel between Brisbane Water and the Kincumber Broadwater.

The Beach Suitability Grade of Poor indicates microbial water quality is susceptible to faecal pollution, particularly after rainfall and occasionally during dry weather conditions, with several potential sources of faecal contamination including stormwater and from elsewhere within Brisbane Water.

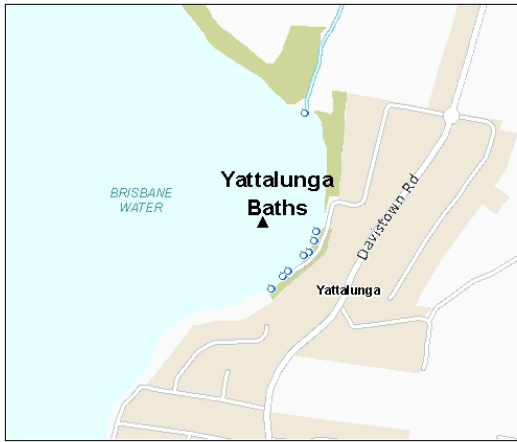
# Yattalunga Baths

Yattalunga Baths is a netted swimming enclosure located in the upper reaches of Brisbane Water.

The Beach Suitability Grade of Poor indicates microbial water quality is susceptible to faecal pollution, particularly after rainfall and occasionally during dry weather conditions, with several potential sources of faecal contamination including stormwater and from elsewhere within Brisbane Water.

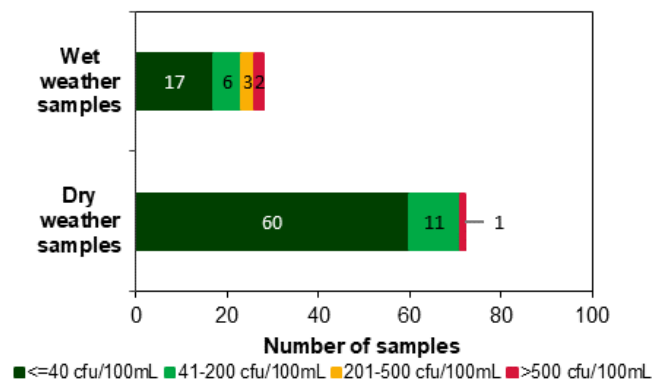
## Wet and dry weather water quality chart

Enterococci levels in wet and dry weather conditions are presented for each swimming location as a bar graph. All data collected during the assessment period is included in the analysis. Dry weather is defined as no rainfall recorded in the previous 24 hours. Each bar is colour coded to show the number of enterococci results up to 40 cfu/100 mL, between 41 and 200 cfu/100 mL, between 201 and 500 cfu/100 mL and greater than 500 cfu/100 mL. These categories reflect the Microbial Assessment Category thresholds and are coloured on the graph as dark green, light green, amber and red respectively.

It is expected that swimming sites with lower levels of flushing will show some elevated bacterial results in dry weather samples (no rainfall in the previous 24 hours) due to the longer time needed to recover from a rainfall event. At some estuarine and lake/lagoon swimming locations the impacts of stormwater pollution on beach water quality may be detected up to 3 days after rainfall.

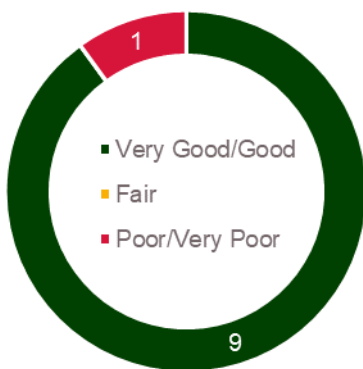
**Beach Suitability Grades for Northern Sydney estuarine beaches**

Barrenjoey Beach, Paradise Beach Baths, Clareville Beach, Taylors Point Baths, North Scotland Island, South Scotland Island, Elvina Bay and Great Mackerel Beach were graded as Good in 2023–2024. Great Mackerel Beach was downgraded to Good from Very Good in the previous year due to declined microbial water quality. Water quality at these sites was suitable for swimming most of the time, with elevated levels of enterococci mostly recorded following rainfall. Bacterial levels were occasionally elevated at Barrenjoey Beach during dry weather conditions.

Bayview Baths was graded as Poor, a consistent result with previous years. Elevated enterococci levels were occasionally recorded during dry weather conditions, and regularly after moderate to heavy rainfall. Water quality at this site can take longer to recover from stormwater events than at other Pittwater swimming sites due to lower levels of flushing.

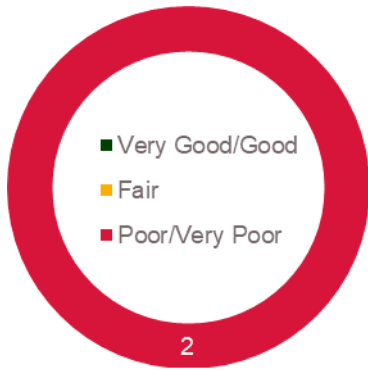
**Beach Suitability Grades for Northern Sydney lake/lagoon swimming sites**

The 2 swimming sites in Narrabeen Lagoon, Birdwood Park and Bilarong Reserve, continued to be graded as Poor in 2023–2024, as in previous years.

Bilarong Reserve in Narrabeen Lagoon retains pollution inputs because it is located away from the lagoon entrance and is not well flushed by clean ocean water. A significant source of faecal contamination is stormwater runoff to the lagoon.

The amount of time the lagoon is open or closed influences water quality at Birdwood Park and Bilarong Reserve lagoon sites. During periods of entrance closure, water quality is likely to decline as pollution inputs are not as readily dissipated or flushed. The lagoon entrance will open and close naturally depending on how much rainfall has occurred and how much sand has accumulated in the mouth. When there are very large accumulations of sand, the entrance will often close and stay closed until the sand is removed by Northern Beaches Council. Historically this process happens every 4–5 years, with the last sand clearance operation being completed in December 2021. With the adoption of the Narrabeen Lagoon Entrance Management Strategy in September 2022, council will be trialling more frequent but smaller sand clearance operations (every 2–3 years rather than 4–5 years).
