## Beachwatch

# State of the beaches 2023–24

Statewide summary and how to read this report

Department of Climate Change,  
Energy, the Environment and Water

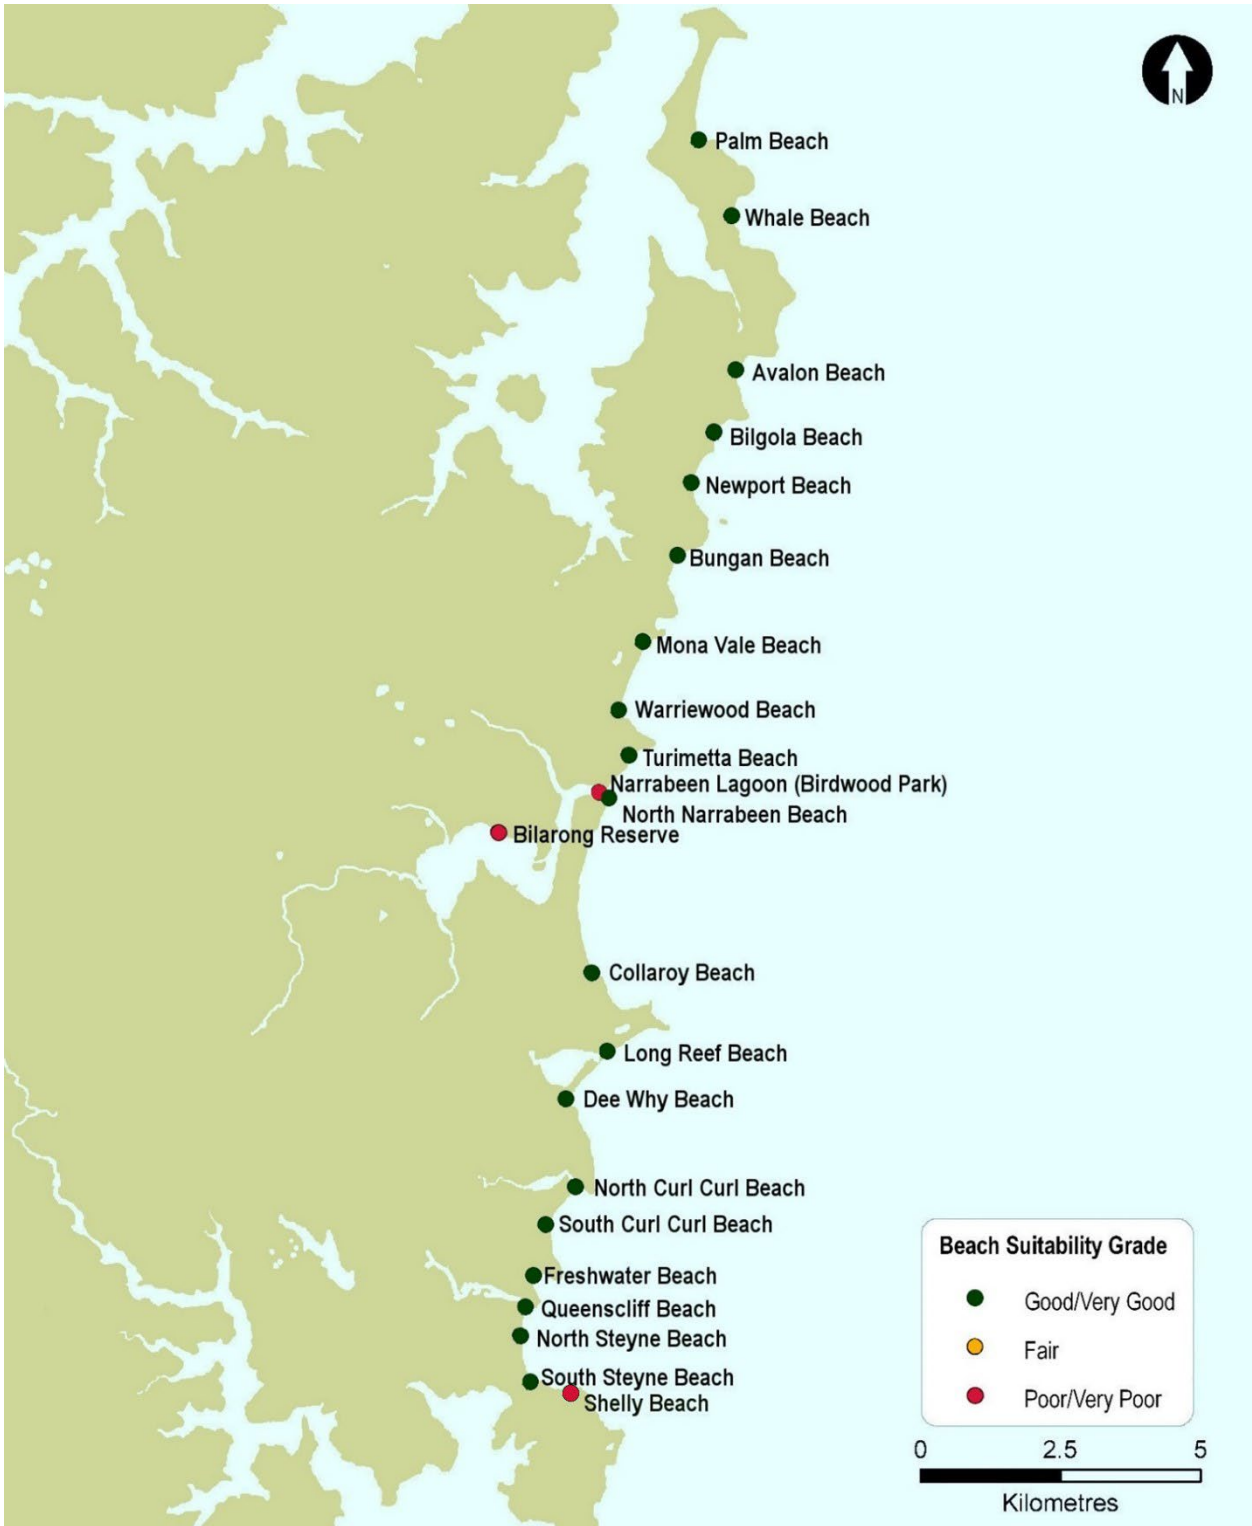
Sampling sites and Beach Suitability Grades at Sydney's Northern Beaches

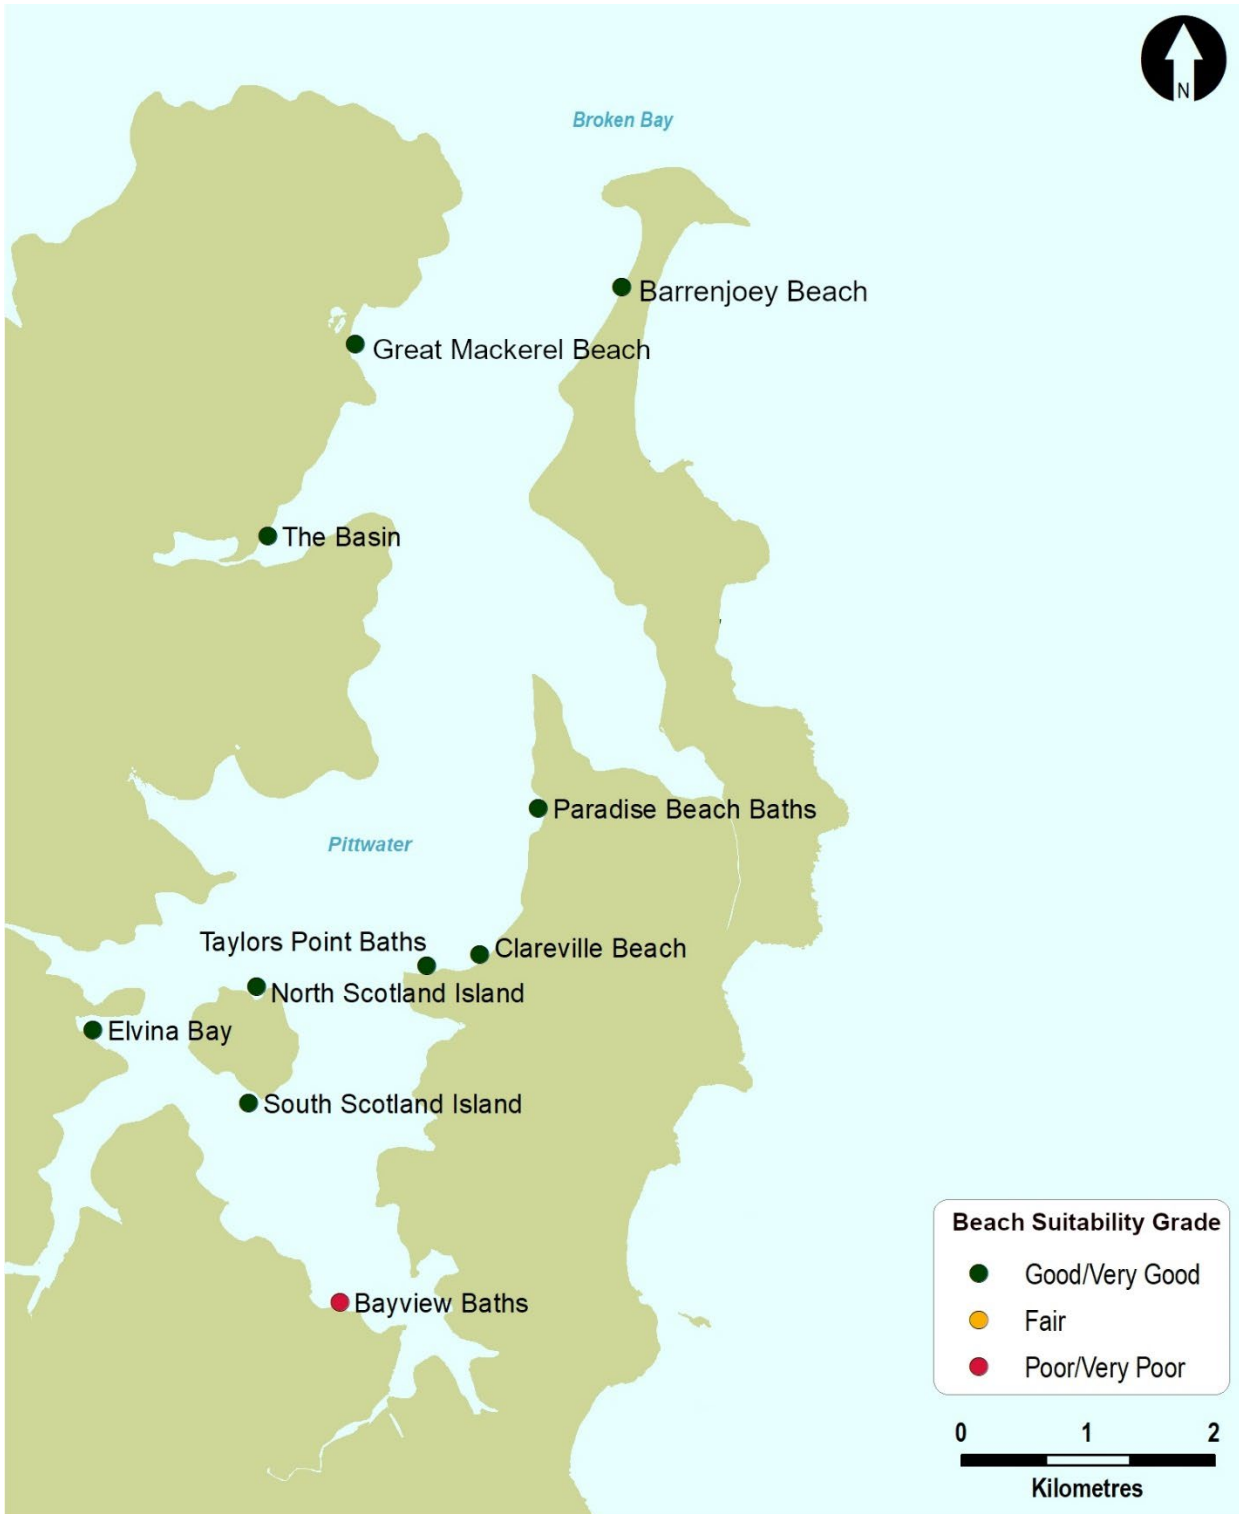
Sampling sites and Beach Suitability Grades in Pittwater

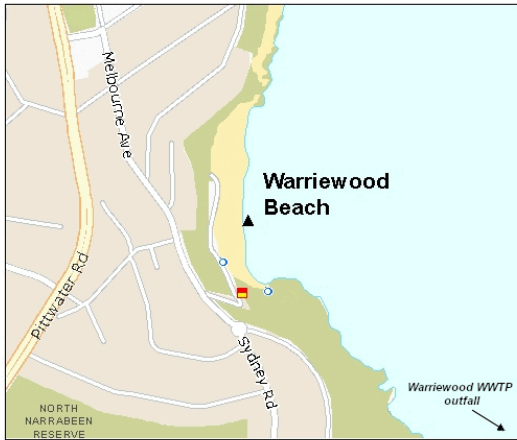
# Warriewood Beach

Warriewood Beach is 500 m long and located below a steep bluff. The beach is patrolled during holiday periods.

The Beach Suitability Grade of Good indicates microbial water quality is considered suitable for swimming most of the time but can be susceptible to pollution after rain, with several potential sources of faecal contamination including Warriewood Wastewater Treatment Plant (WWTP).

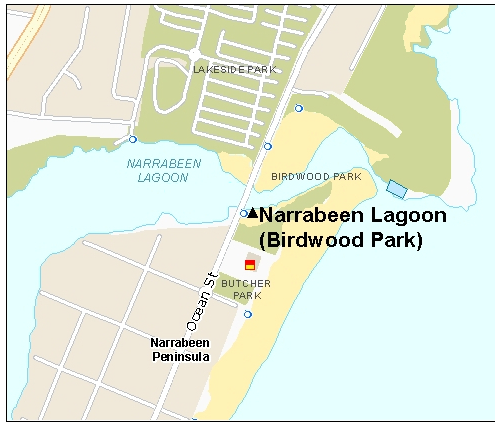
# Narrabeen Lagoon (Birdwood Park)

The Birdwood Park swimming site is a sandy beach on the southern side of the entrance to Narrabeen Lagoon. The lagoon entrance has been periodically open and closed at times.

The Beach Suitability Grade of Poor indicates microbial water quality is susceptible to faecal pollution, particularly after rainfall and occasionally during dry weather conditions, with several potential sources of faecal contamination including from elsewhere within the lagoon.

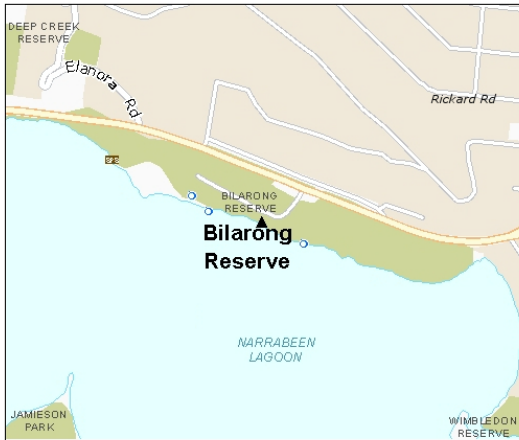
# Bilarong Reserve

Bilarong Reserve is located on the northern shoreline of Narrabeen Lagoon.

The Beach Suitability Grade of Poor indicates microbial water quality is susceptible to faecal pollution, particularly after rainfall and occasionally during dry weather conditions, with several potential sources of faecal contamination including from elsewhere within the lagoon.

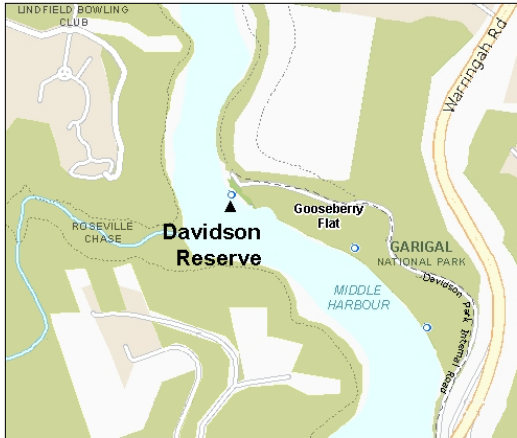
# Davidson Reserve

Davidson Reserve is a 25 m long swimming area situated in Middle Harbour and is backed by Garigal National Park and picnic area. The Beach Suitability Grade of Poor indicates microbial water quality is susceptible to faecal pollution, particularly after rainfall and occasionally during dry weather conditions, with several potential sources of faecal contamination including sewage overflows and upstream sources in Middle Harbour.

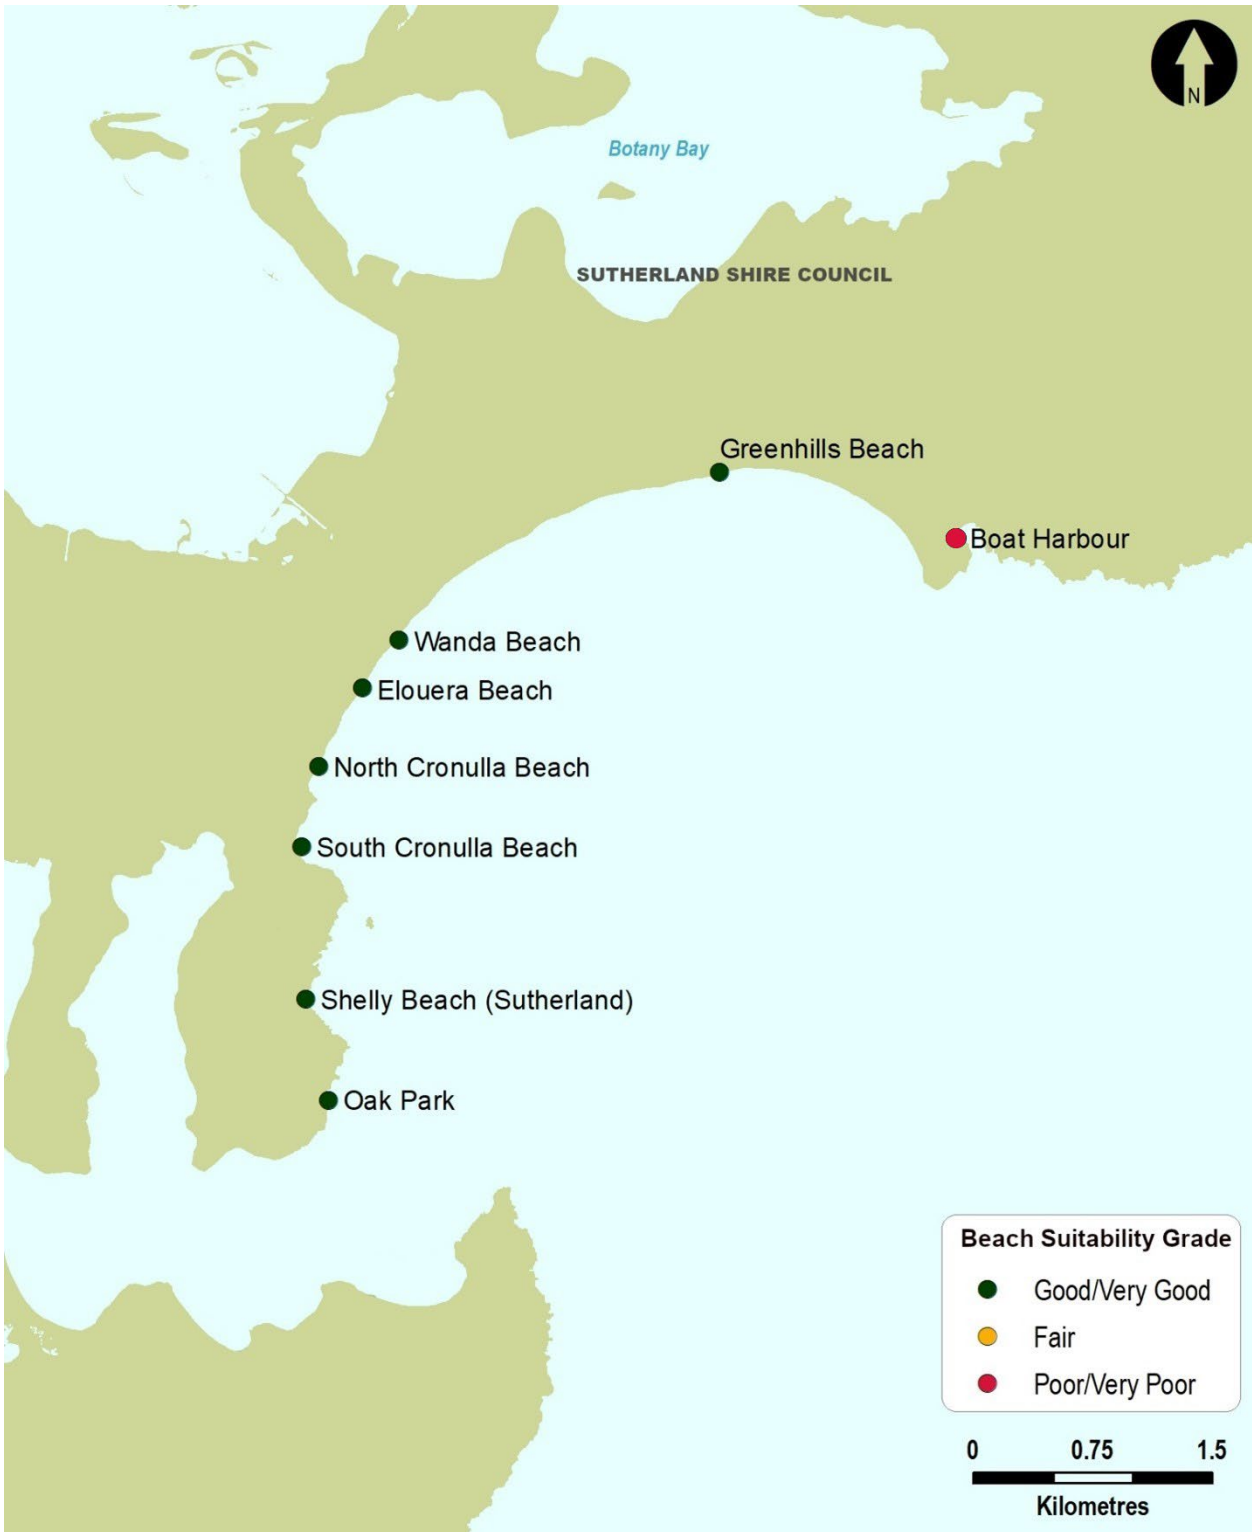
Sampling sites and Beach Suitability Grades at Sydney's Southern beaches

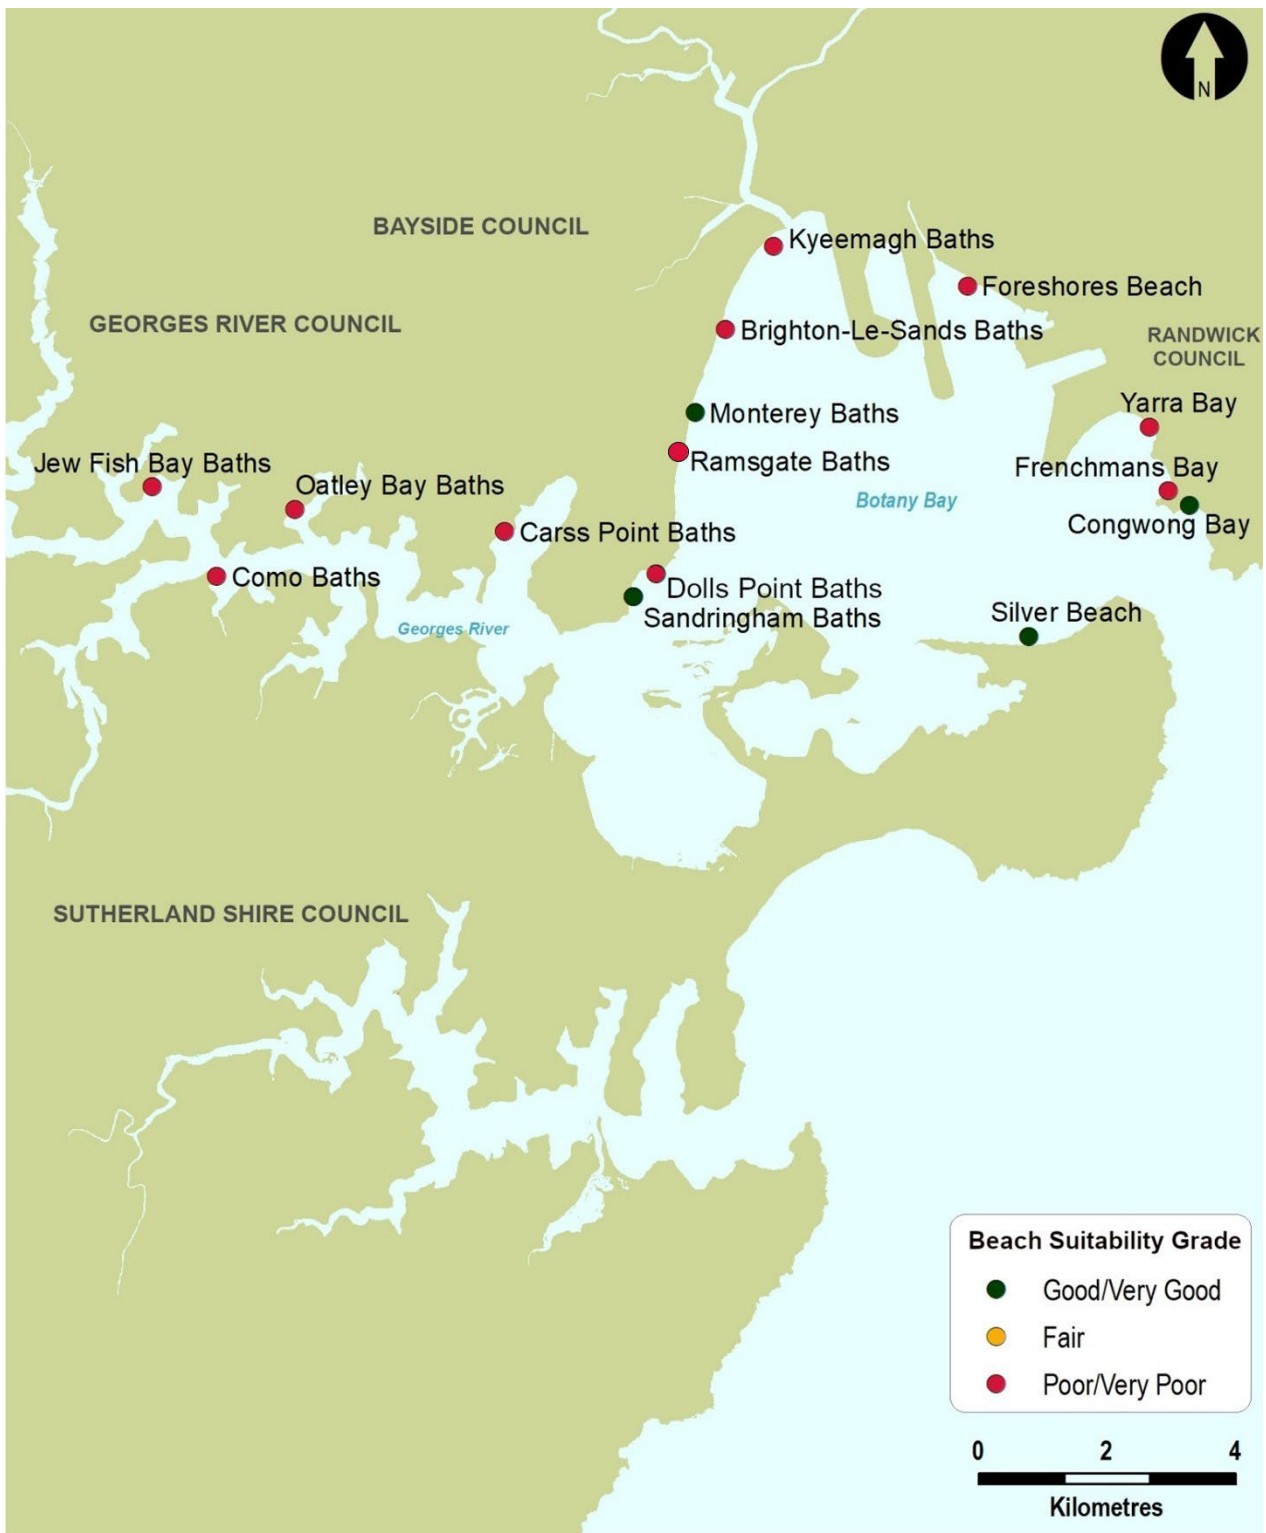
Sampling sites and Beach Suitability Grades in Botany Bay and lower Georges River

Eleven estuarine swimming sites were graded as Poor in 2023–2024: Como Baths, Jew Fish Bay Baths, Oatley Bay Baths and Carss Point Baths in the lower Georges River, Dolls Point Baths, Ramsgate Baths, Brighton-Le-Sands Baths, Kyeemagh Baths, Yarra Bay and Frenchmans Bay in Botany Bay, and Gunnamatta Bay Baths in Port Hacking. Microbial water quality at these sites was mostly suitable for swimming during dry weather conditions, with between 53% and 83% of dry weather samples within the safe swimming limit. However, bacterial levels increased significantly with increasing rainfall. These sites can be susceptible to wet weather impacts and have several sources of faecal contamination including upstream sources, stormwater and sewage overflows and chokes.

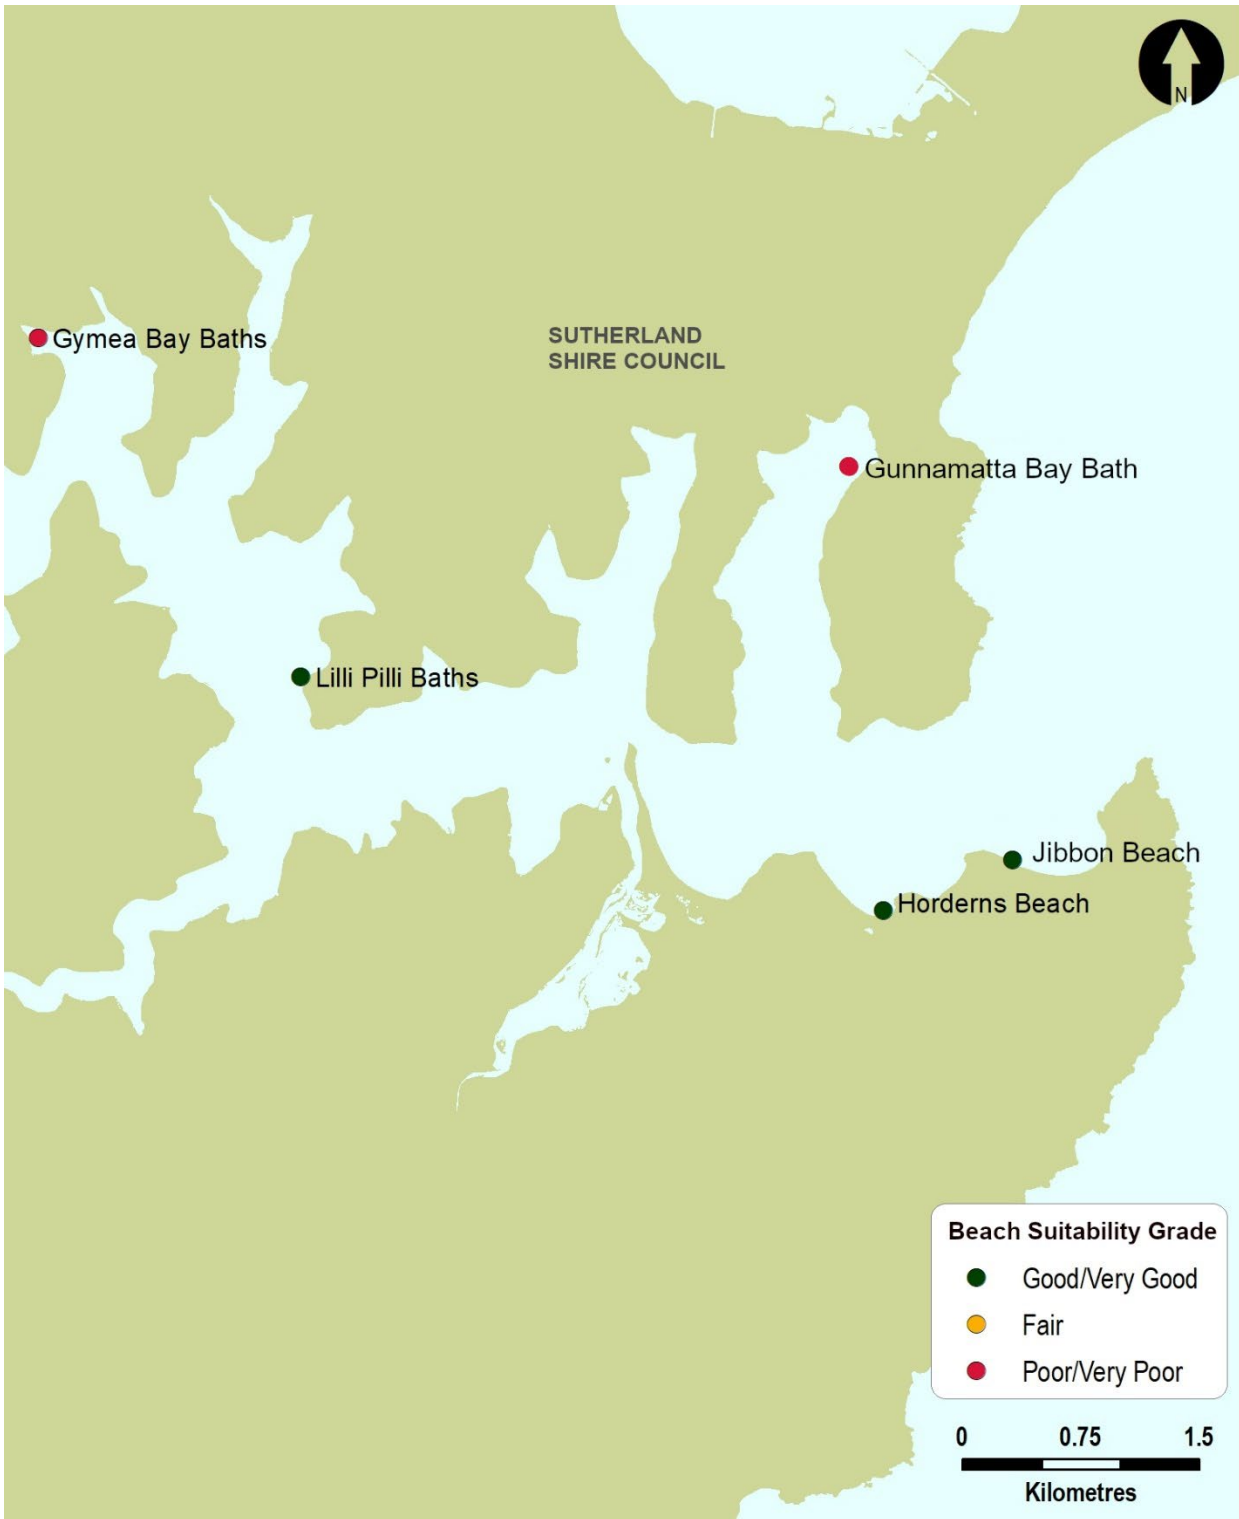
Sampling sites and Beach Suitability Grades in Port Hacking

Microbial water quality at Gymea Bay Baths has shown trends of declining microbial assessments over the last 5 years. This site is susceptible to faecal contamination with many potential sources including stormwater, sewer chokes and from elsewhere within Port Hacking.

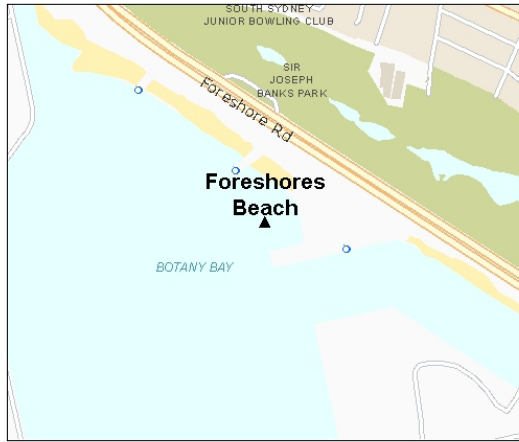
# Foreshores Beach

Foreshores Beach is an unnetted sandy beach in Botany Bay. It is located near a boat ramp, and is adjacent to the Sydney Airport runway and Port Botany.

The Beach Suitability Grade of Very Poor indicates microbial water quality is very susceptible to faecal pollution with many potential sources of faecal contamination including stormwater and sewage overflows that discharge into Mill Stream.

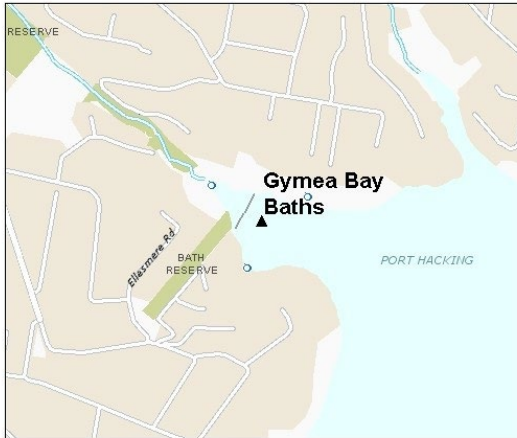
# Gymea Bay Baths

Gymea Bay Baths is an enclosed tidal swimming area backed by a narrow sandy beach in the upper reaches of Port Hacking.

The Beach Suitability Grade of Very Poor indicates microbial water quality is very susceptible to faecal pollution with many potential sources of faecal contamination including stormwater.

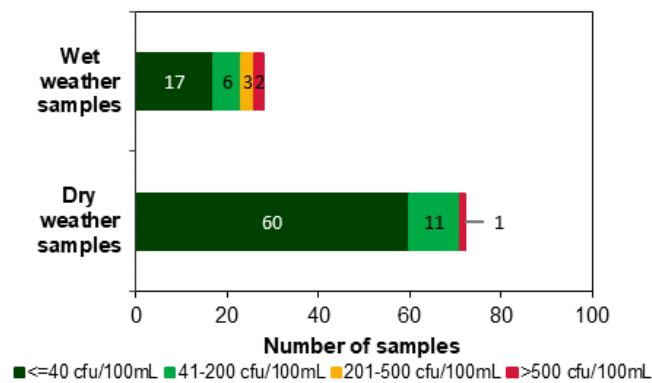
## Wet and dry weather water quality chart

It is expected that swimming sites with lower levels of flushing will show some elevated bacterial results in dry weather samples (no rainfall in the previous 24 hours) due to the longer time needed to recover from a rainfall event. At some estuarine and lake/lagoon swimming locations the impacts of stormwater pollution on beach water quality may be detected up to 3 days after rainfall.

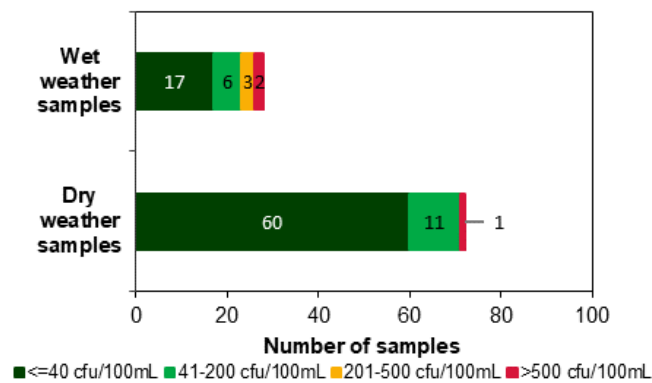
## Wet and dry weather water quality chart

It is expected that swimming sites with lower levels of flushing will show some elevated bacterial results in dry weather samples (no rainfall in the previous 24 hours) due to the longer time needed to recover from a rainfall event. At some estuarine and lake/lagoon swimming locations the impacts of stormwater pollution on beach water quality may be detected up to 3 days after rainfall.

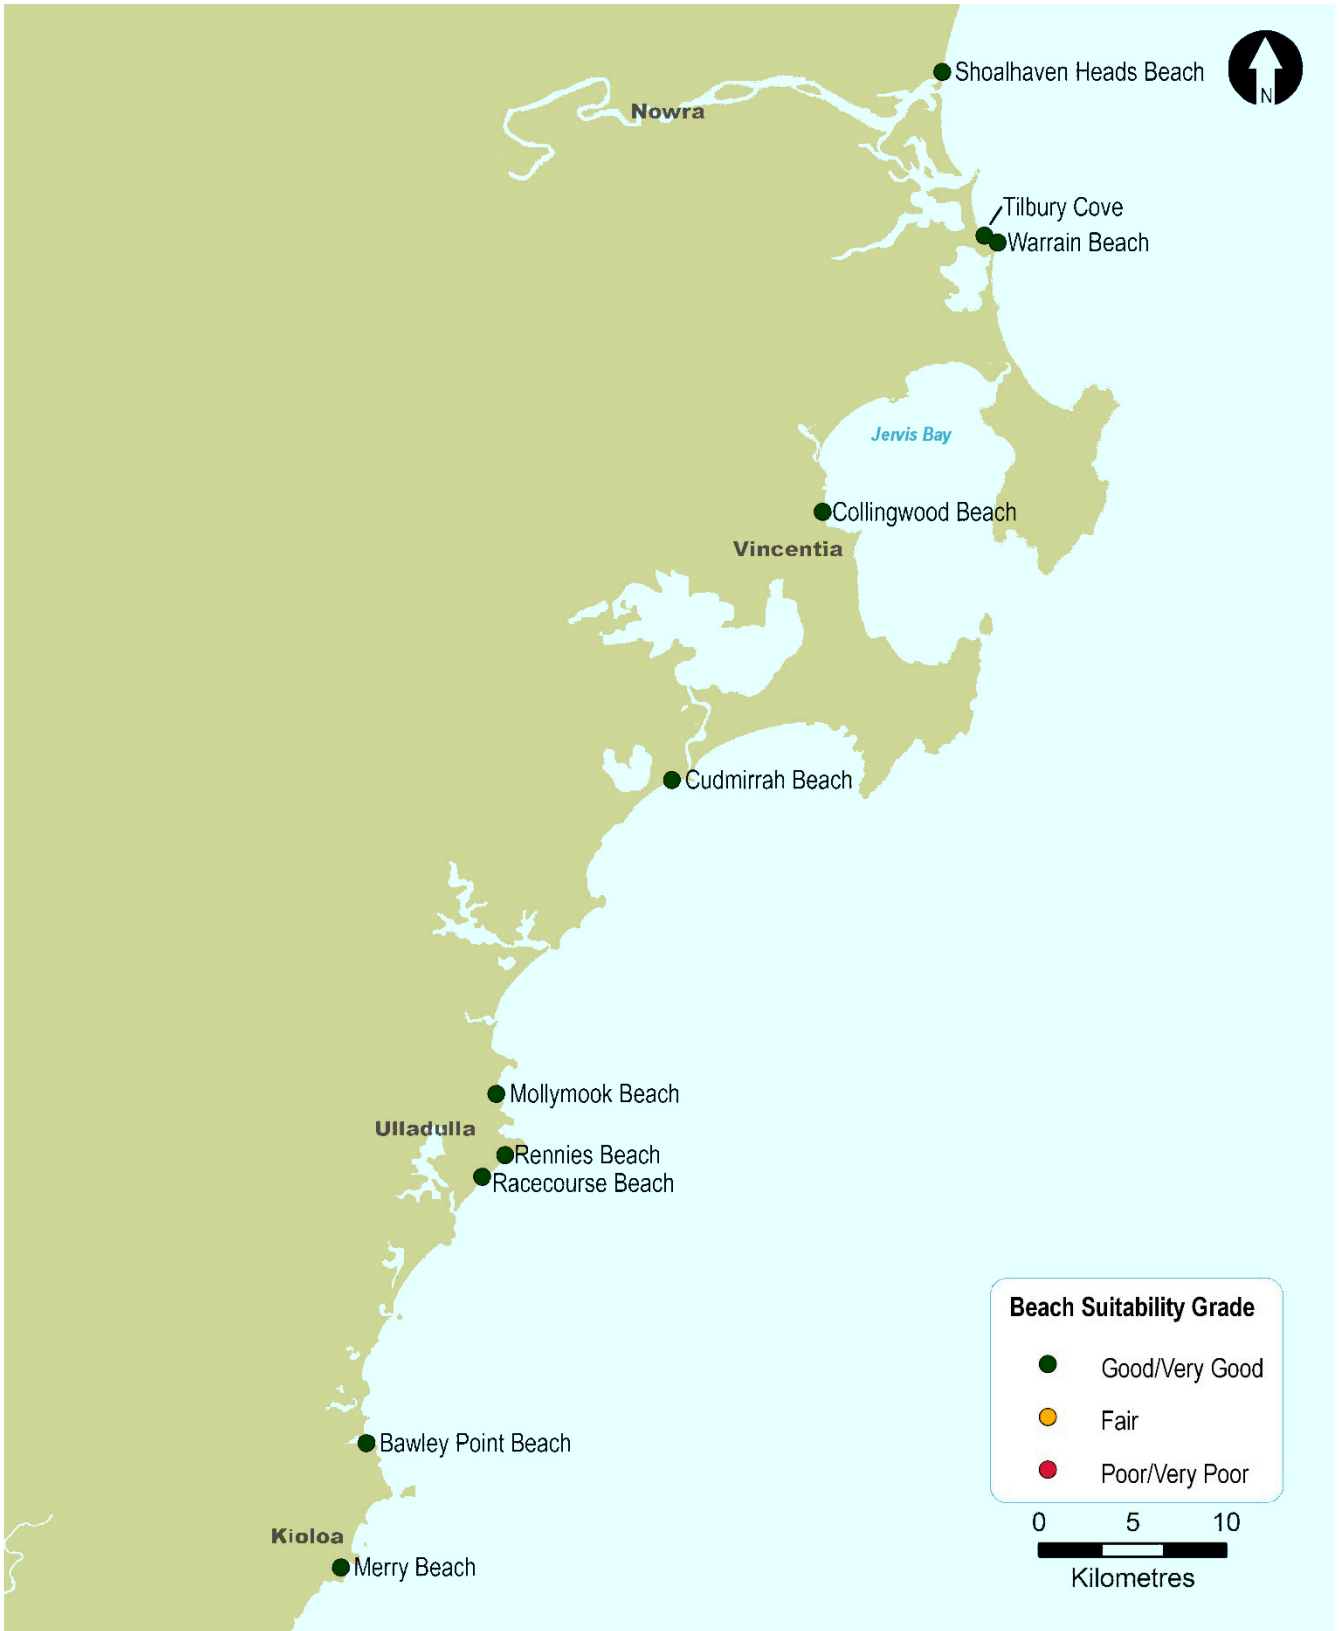
Sampling sites and Beach Suitability Grades in Shoalhaven City Council

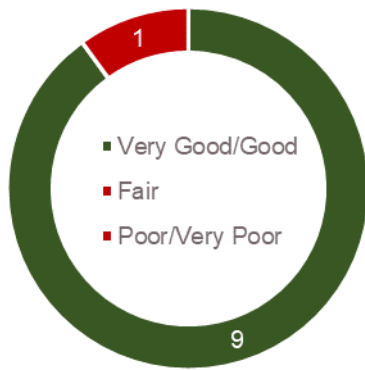
**Beach Suitability Grades for Eurobodalla Shire Council ocean beaches**

Nine of the 10 ocean beaches were graded as Very Good or Good in 2023–2024.

Caseys Beach, South Broulee (Bengello) Beach, Shelley Beach, Tuross Main Beach and Narooma Main Beach were graded as Good in 2023–2024. Water quality at these sites was frequently suitable for swimming during dry weather conditions, with between 90% and 97% of dry weather samples within the safe swimming limit. However, enterococci levels occasionally exceeded the safe swimming limit after little or no rain. South Broulee (Bengello) Beach declined to Good from Very Good in the previous year due to a slight decline in microbial water quality in the assessment period.

Surf Beach was graded as Poor in 2023–2024, consistent with the previous years. Elevated bacterial levels were often recorded during dry weather conditions and increased with increasing rainfall. Despite this, 77% of dry weather samples were within the safe swimming limit.

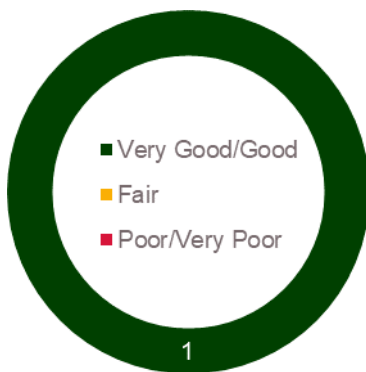
**Beach Suitability Grades for Eurobodalla Shire Council estuarine beaches**

Wagonga Inlet continued to be graded as Good in 2023–2024, similar to previous years. While water quality at this site was mostly suitable for swimming, elevated enterococci results were occasionally recorded after light rain, and often after moderate rainfall. Pollution inputs from elsewhere within Wagonga Inlet may impact water quality at this site.

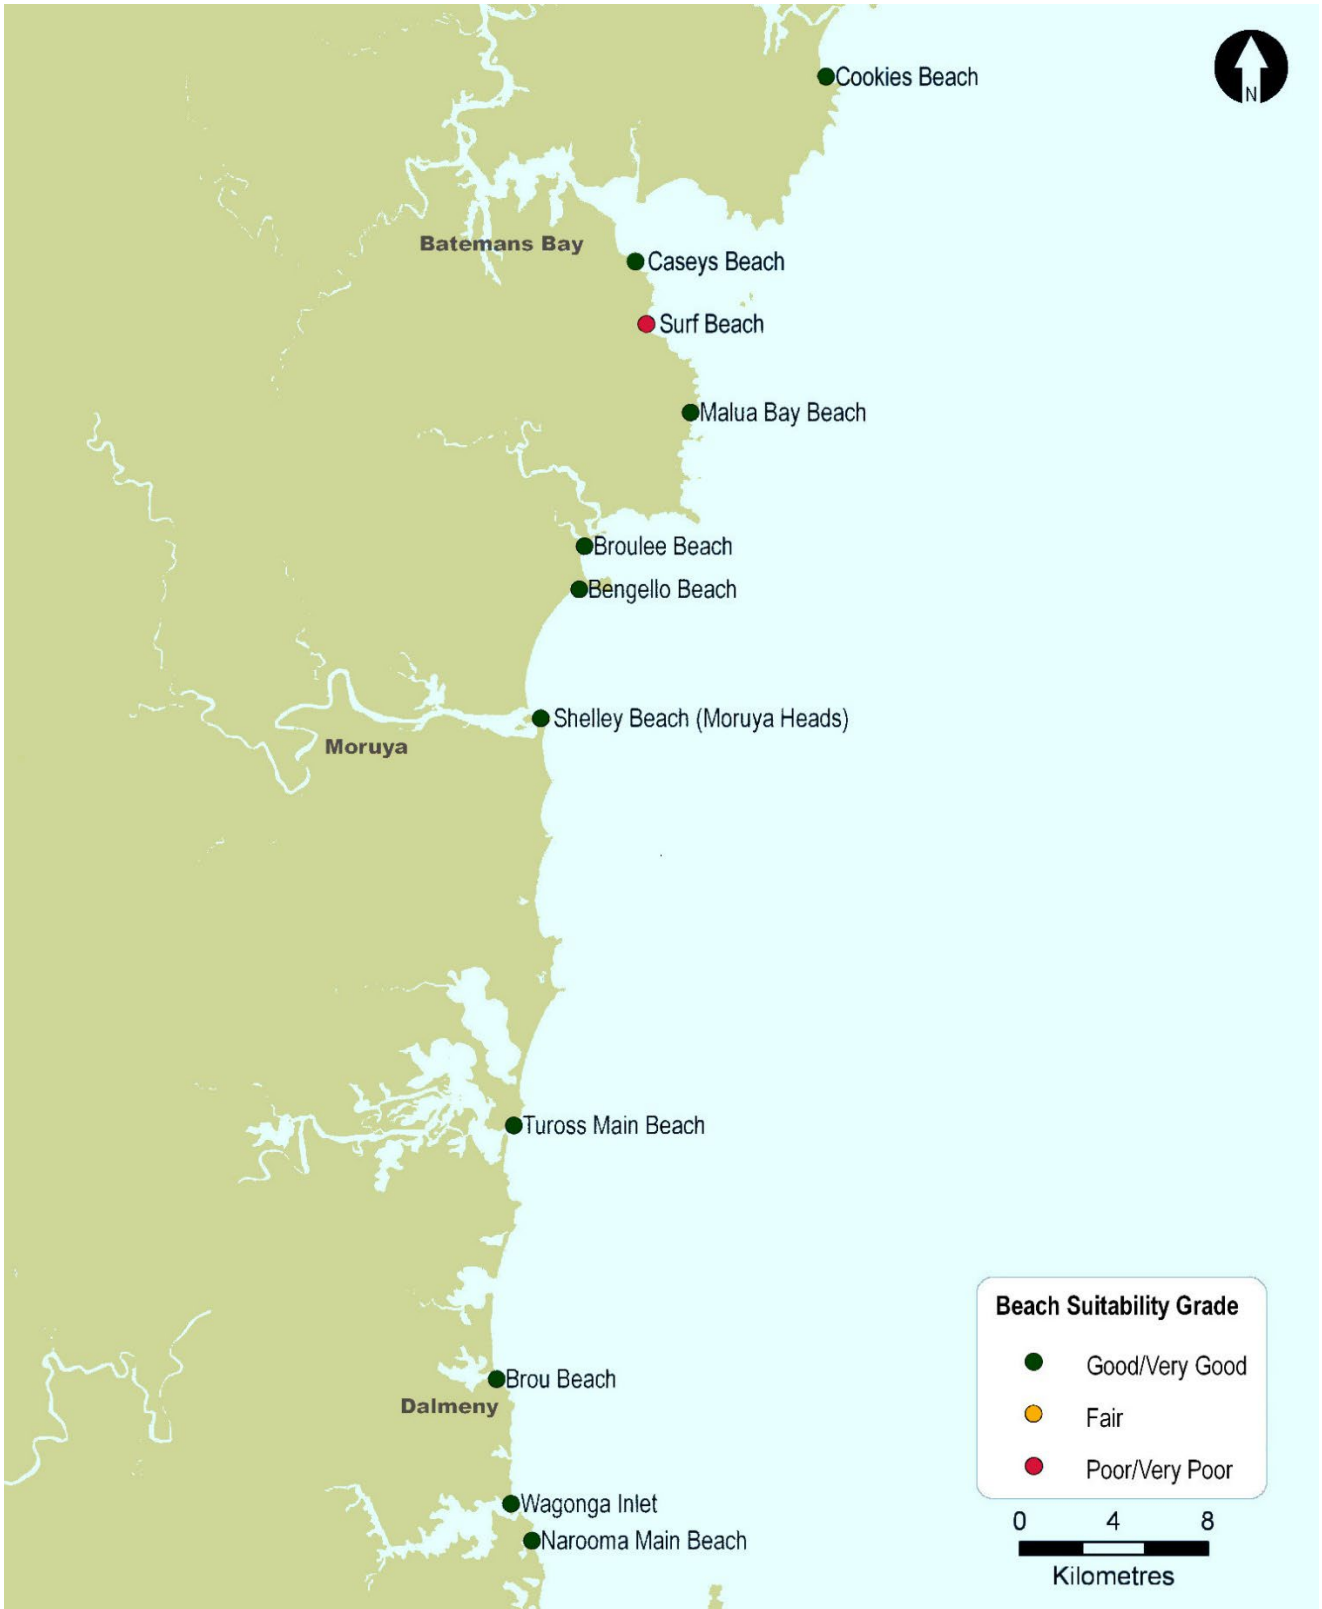
**Sampling sites and Beach Suitability Grades in Eurobodalla Shire Council**

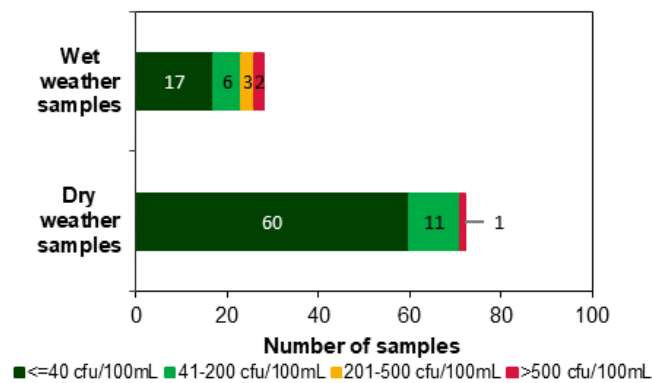
## Wet and dry weather water quality chart

It is expected that swimming sites with lower levels of flushing will show some elevated bacterial results in dry weather samples (no rainfall in the previous 24 hours) due to the longer time needed to recover from a rainfall event. At some estuarine and lake/lagoon swimming locations the impacts of stormwater pollution on beach water quality may be detected up to 3 days after rainfall.
